Otak, Inc.
May 2017

Critical Areas Study East Lake Sammamish Master Plan Trail South Sammamish Segment B

October 2016

Critical Areas Study East Lake Sammamish Master Plan Trail - South Sammamish Segment B

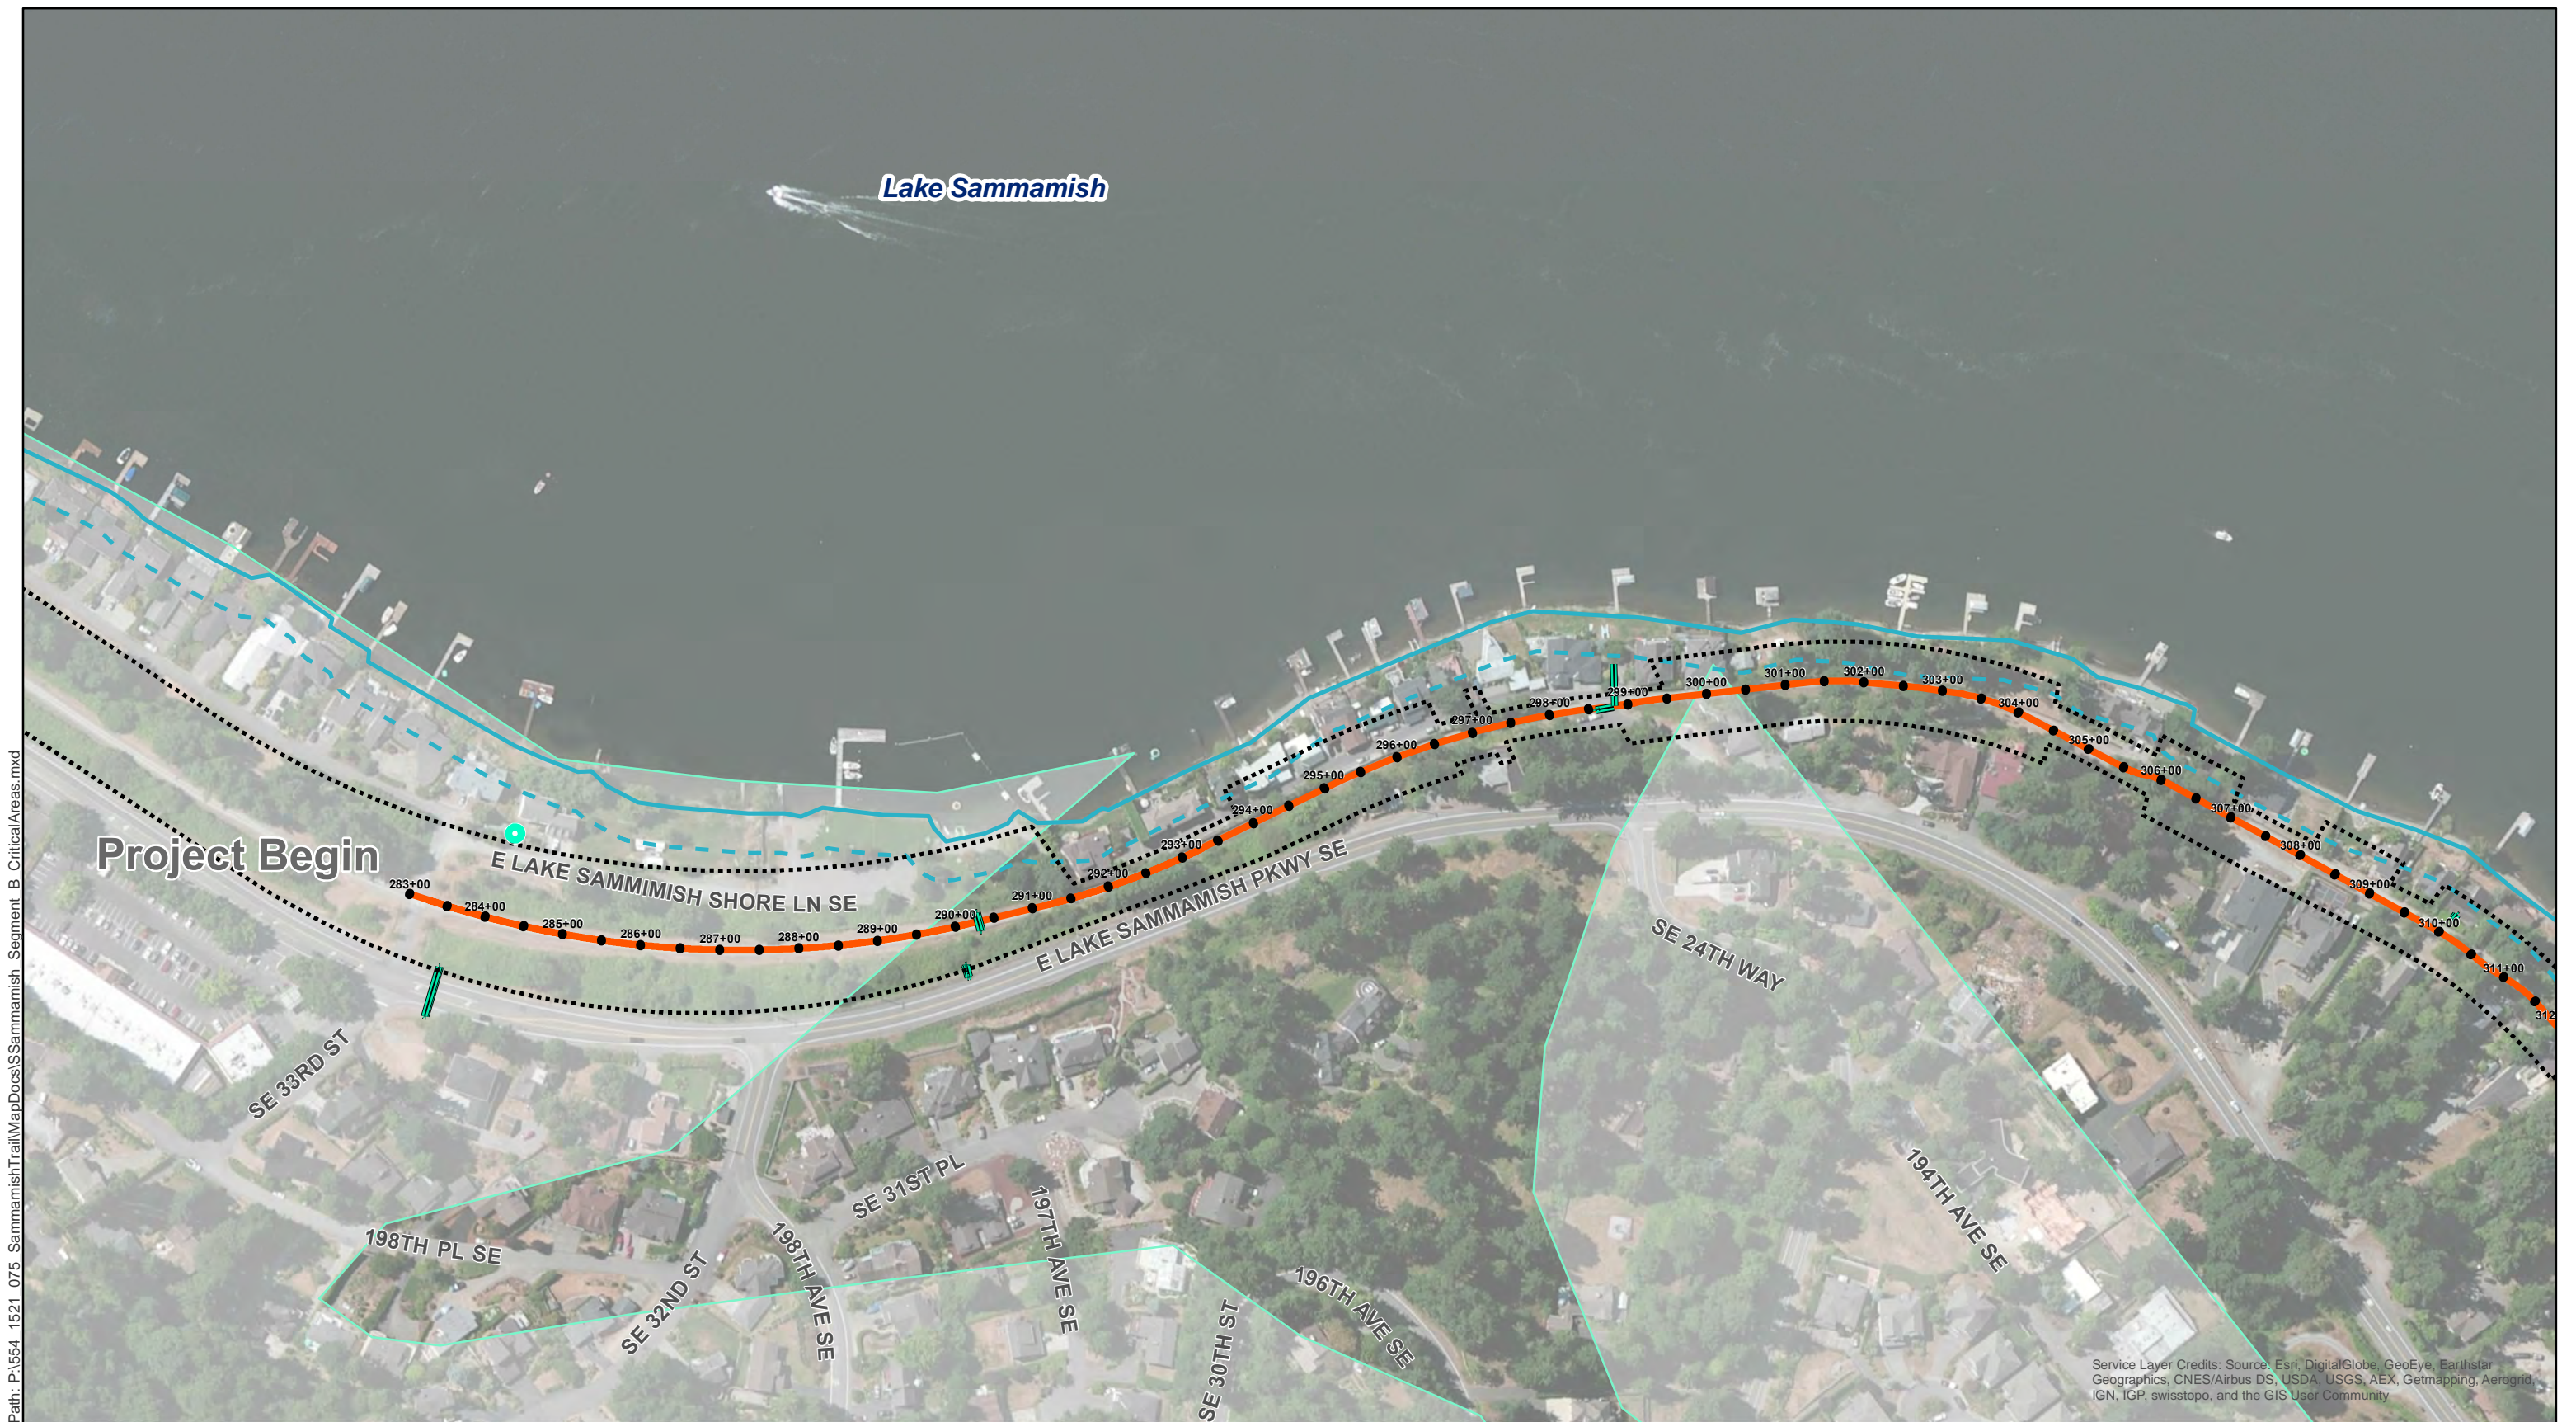
Figure 3-2a
Critical Areas Map
East Lake Sammamish Master Plan Trail
South Sammamish -
Segment B

- Proposed Trail
- Wetland
- Stream Buffer
- Wetland Buffer
- Wetland and Buffer Continues
- Delineated Wetland Boundary
- Stream
- Lake OHWM
- Shoreline Setback
- Culvert
- Class 3 Wellhead Protection Zone
- Group B Well
- Project Right of Way

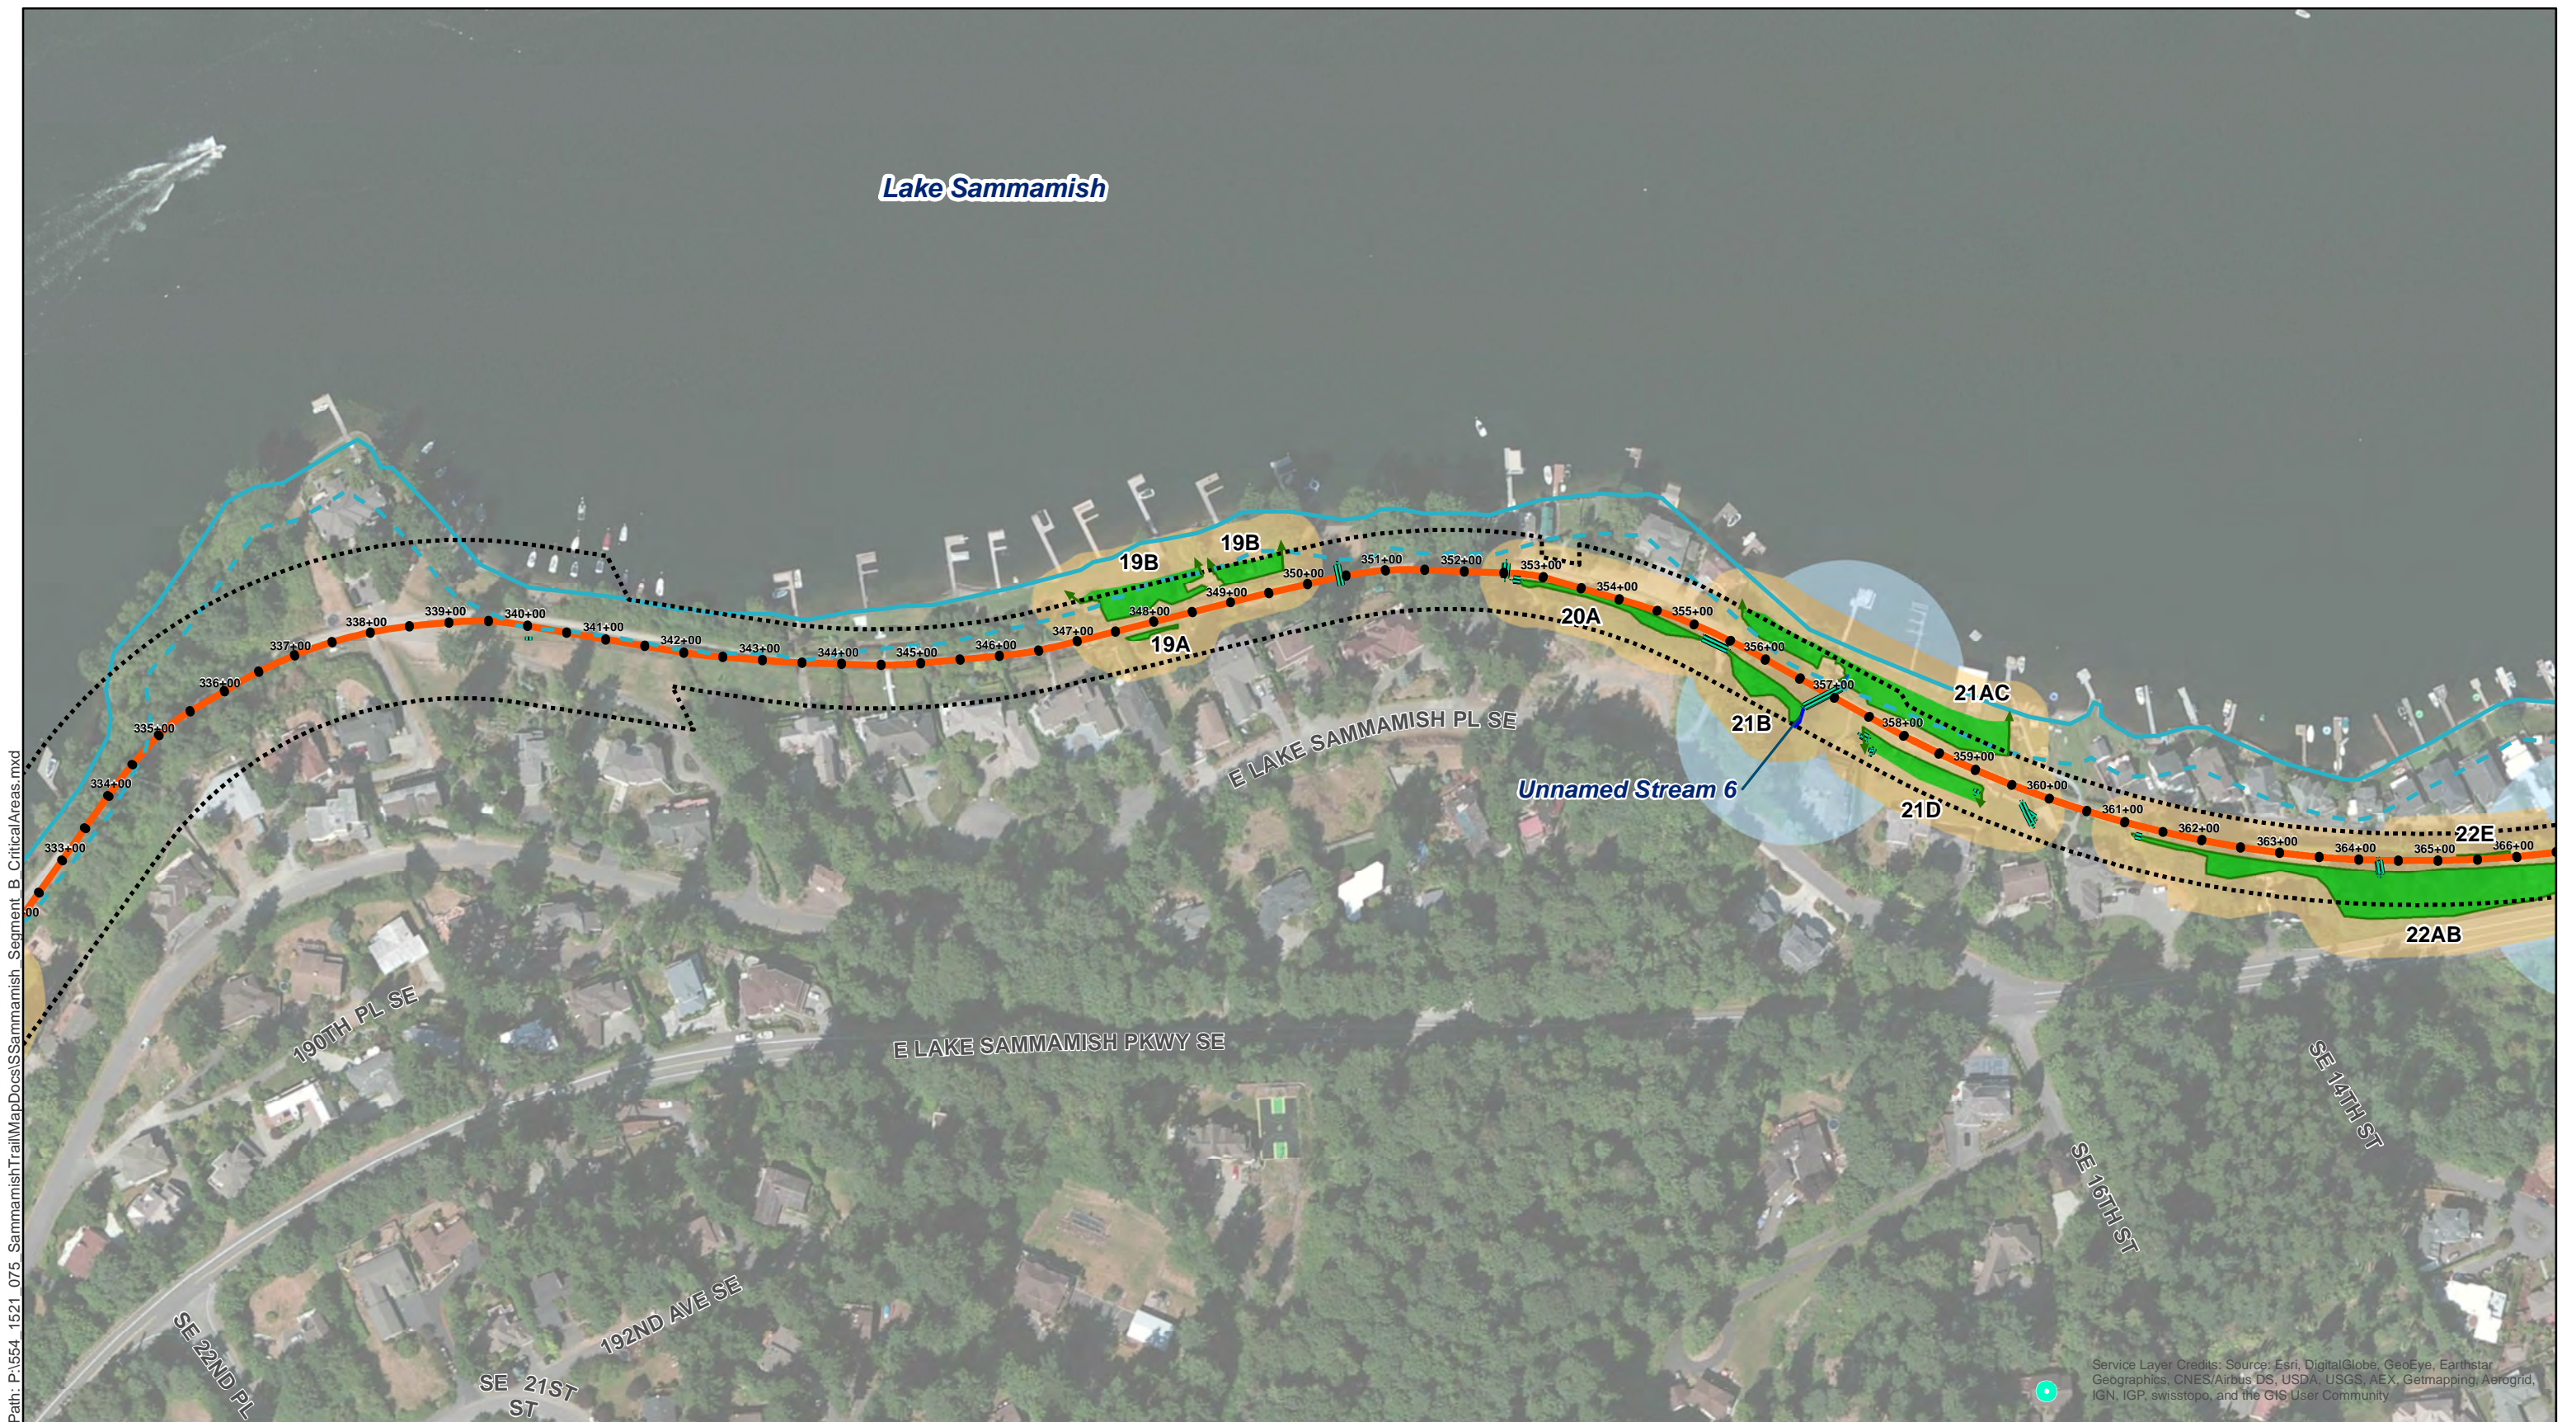
Figure A
Critical Areas Map
East Lake Sammamish Master Plan Trail
South Sammamish -
Segment B

- Proposed Trail
- Wetland
- Stream Buffer
- Wetland Buffer
- Wetland and Buffer Continues
- Delineated Wetland Boundary
- Stream
- Lake OHWM
- - Shoreline Setback
- Culvert
- Class 3 Wellhead Protection Zone
- Group B Well
- Project Right of Way
