Final Zackuse Basin Plan

June 7, 2019

OSBORN
CONSULTING
INCORPORATED

THE
WATERSHED
COMPANY

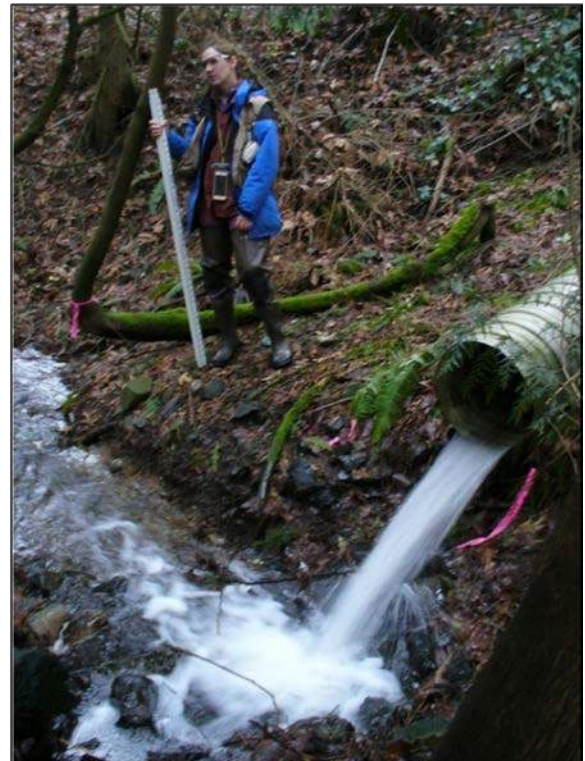
The mainstem of Zackuse Creek was walked in January 2018. The Zackuse mainstem originates in a pipe (Photo 5-1) that conveys stormwater runoff from Louis Thompson Road NE and water from headwater wetlands on 212th Avenue SE and the Cedarwood Estates development (Figure 4-1). The stream channels and adjacent hillslopes are not stable in the upper reach. The channel in the upper reach is highly confined to a narrow channel, approximately 3 feet wide, with steep-sided banks and has an average slope of about 10 to 15%. The bed consists of large boulders and cobbles. A landslide occurred in November 2015, on the right bank of the stream, adjacent to Louis Thompson Road NE and at the base of an existing soldier pile wall as a result of drainage discharges. A capital project was completed in winter 2018 to repair the slide and improve the drainage between 210th PI SE and 211th PI SE, including installation of a new outfall in Zackuse Creek that conveys stormwater runoff from 210th PI NE (Photo Z-42a in Appendix B). An outfall (Outfall No. 04) that discharges stormwater from Louis Thompson Road NE to the hill slope above Zackuse Creek has caused additional erosion, just west of the slide location (Photo Z-35 in Appendix B). Large rocks and wood have been placed on the hill slope to stabilize the slope and prevent additional erosion. These efforts have only been marginally successful, as evidence in the field showed that the large material is being undermined. The capital project completed in winter 2018, rerouted most of the runoff that previously went to this outfall to a new outfall at the start of the stream channel.

Photo 5-1. Headwaters of Zackuse Creek. Creek flow originates in 18-inch-diameter pipe, as shown above. Photo taken looking north on January 12, 2018.

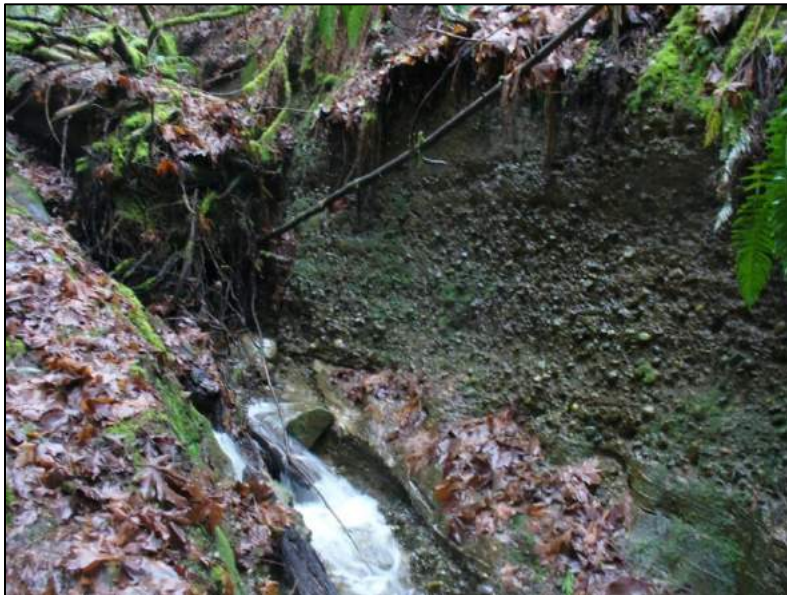
Photo 5-2. Zackuse Creek downcutting through advance outwash deposits. January 12, 2018.

Downcutting (i.e., channel erosion) is also prevalent in some locations in the upper reach. Sand and gravel in the channel banks are exposed by the stream channel actively cutting its way through this material, which is lowering the bed (Photo 5-2).

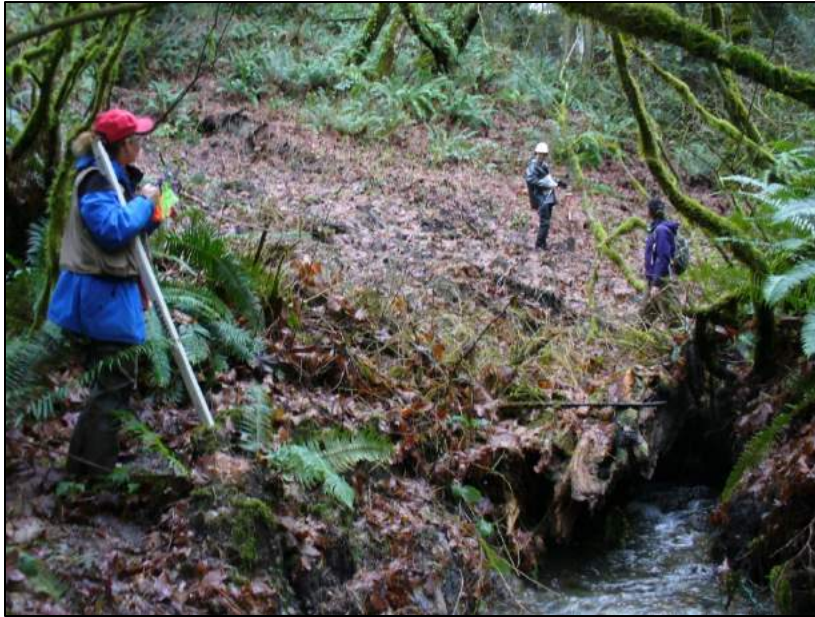
Photo 5-3. Landslide upstream of 206th Avenue NE. Slide deposited material in the stream channel, which subsequently cut a path through, leaving a bench on the left bank (shown on the right side of the photo). January 12, 2018.

Once out of the fine-grained pre-Fraser geologic material, in the downstream direction, the channel once again cuts through sand and gravel deposits (mapped as recessional outwash). The channel is steeper and confined by steep hill slopes. Two slope failures are present on the right bank just upstream of 206th Avenue NE. The larger and more recent landslide occurred in March 2017 and is immediately upstream of 206th Avenue NE. It is approximately 60 feet wide at its base by about 50 feet high. The slide deposited material in Zackuse Creek when the slope originally failed. The creek subsequently cut through the material leaving a bench of sediment on both sides of the channel.

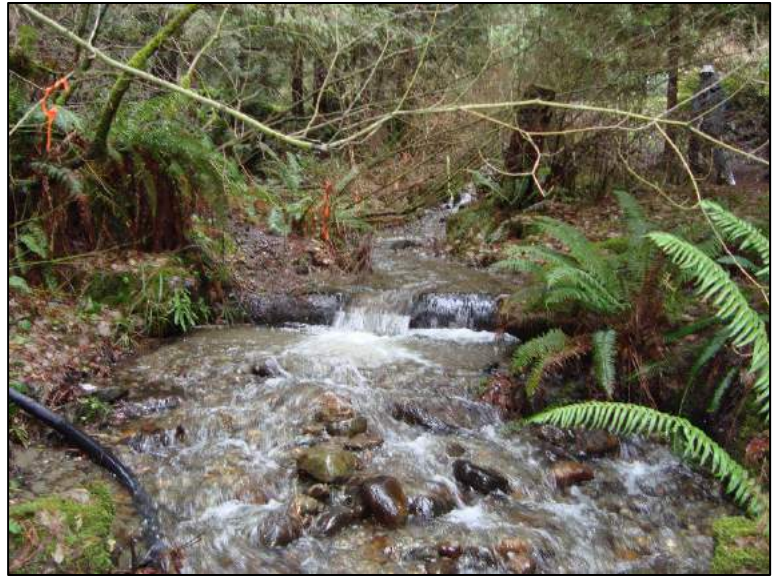
Photo 5- 5. Log grade control structure in channel downstream of confluence with south tributary. Pipe shown on the left of photo is water intake for salmon incubation boxes. January 12, 2018.

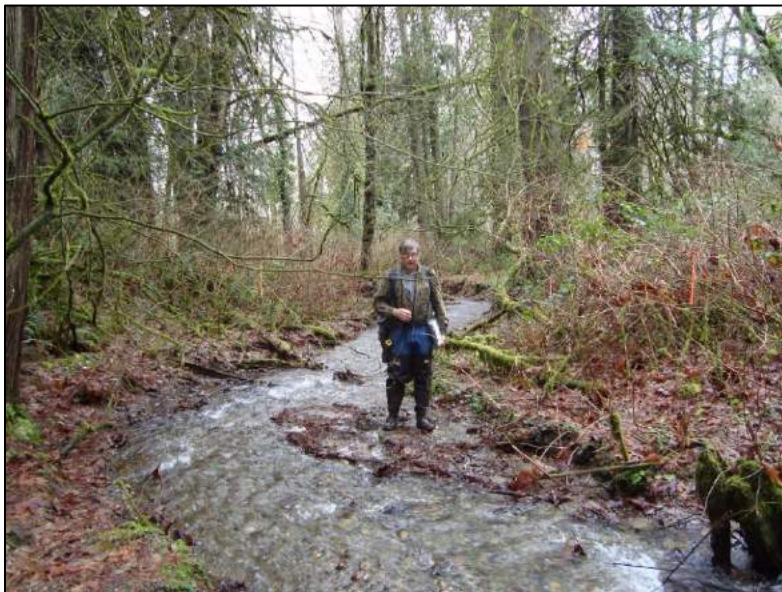
Photo 5- 6. Typical channel characteristics in lower reach. Channel is wider and shallower, and grain size distribution in bed is smaller. January 12, 2018.

depth), and the grain size is finer (Photo 5-6). Bed material consists of large gravel (1 to 2 inches in diameter) with some cobbles and sand. The channel in this reach is very active, and there is evidence of channel movement back and forth across the floodplain area over the past many decades. Earlier maps show the Zackuse Creek (formerly Eden Creek on some documents) channel to be located to the north of its current location. A dry channel bed was observed to the north of Zackuse Creek during the site

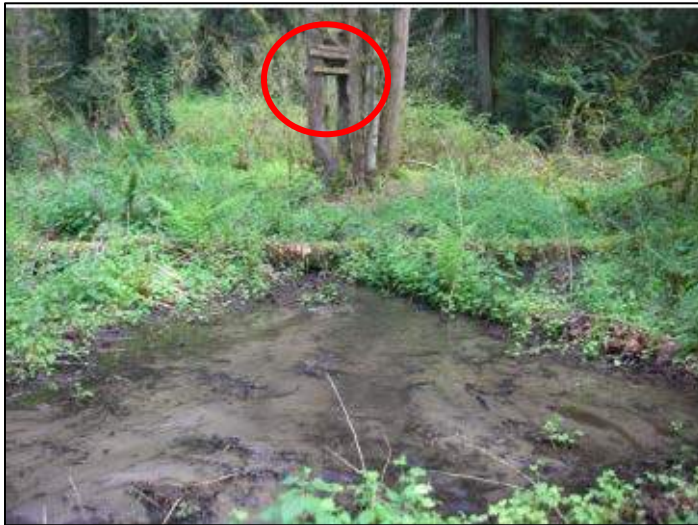
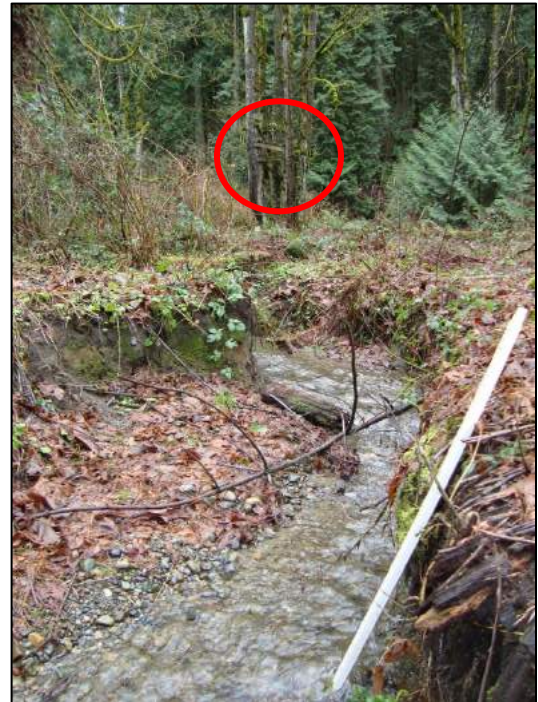
Photo 5-7a (left) and 5-7b (right). Photo on left shows Zackuse Creek in 2012 (notice shallow, dispersed flow). Photo on the right is in the same location in January 2018. Channel has incised several feet. Red circle shows clump of trees for reference in each photo.

A comparison of photo evidence from previous documentation in 2012 and 2018 shows that the channel has downcut at least 3 feet to form a new channel just upstream of the dogleg (Photos 5-7a and 5-7b).

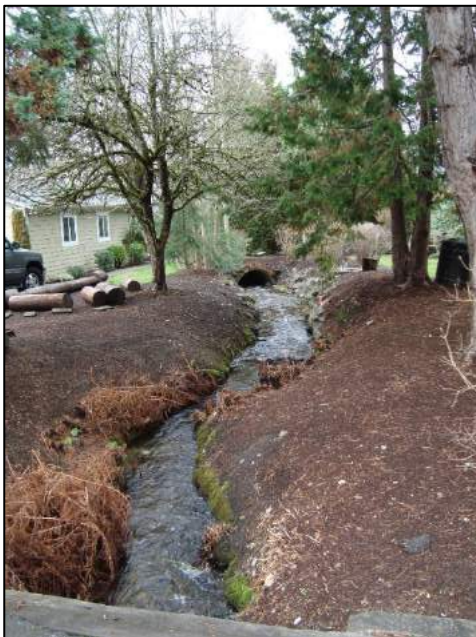
Downstream of the culvert replacements, between the trail and the mouth at Lake Sammamish, the channel is confined to a narrow, relatively straight, and uniform path that is armored to contain flow within its banks and prevent movement to adjacent properties (Photo 5-8). This section of Zackuse Creek was piped prior to 2009. In 2009, a project by the King Conservation District, in conjunction with a private property owner, removed the pipe and daylighted this section of the Creek.

Photo 5- 8. Typical channel section downstream of E Lake Sammamish Parkway. Photo is looking downstream. January 12, 2018.

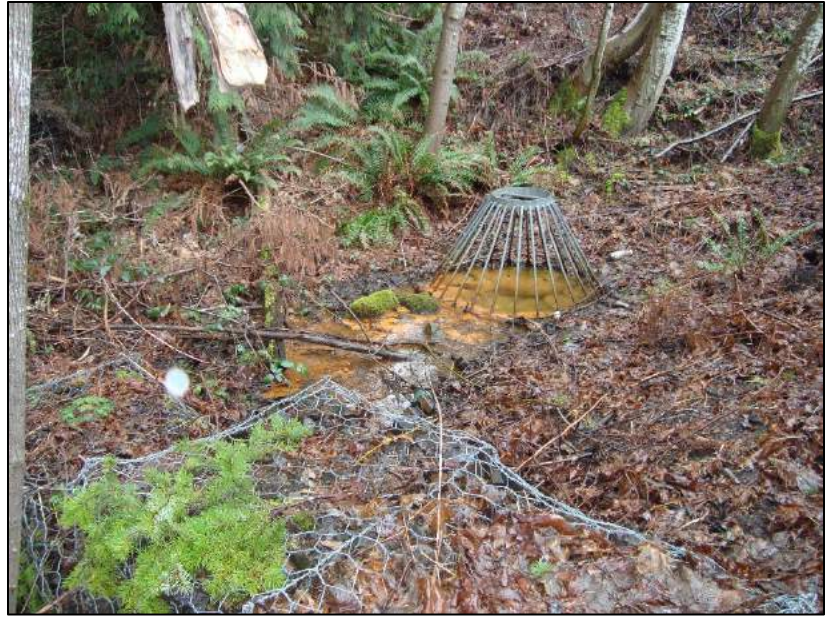
The south tributary of Zackuse Creek was walked in March 2018. The south tributary originates in the Montage neighborhood from a pipe that discharges in a birdcage structure (Photo 5-9) within a depression at the head of a ravine. Two rows of gabion baskets filled with cobbles are located downstream of the birdcage; these provide energy dissipation during high flows.

Photo 5-9. South tributary headwaters, looking upstream from first row of gabions. Orange scum on water surface is the result of oxidation. March 8, 2018.

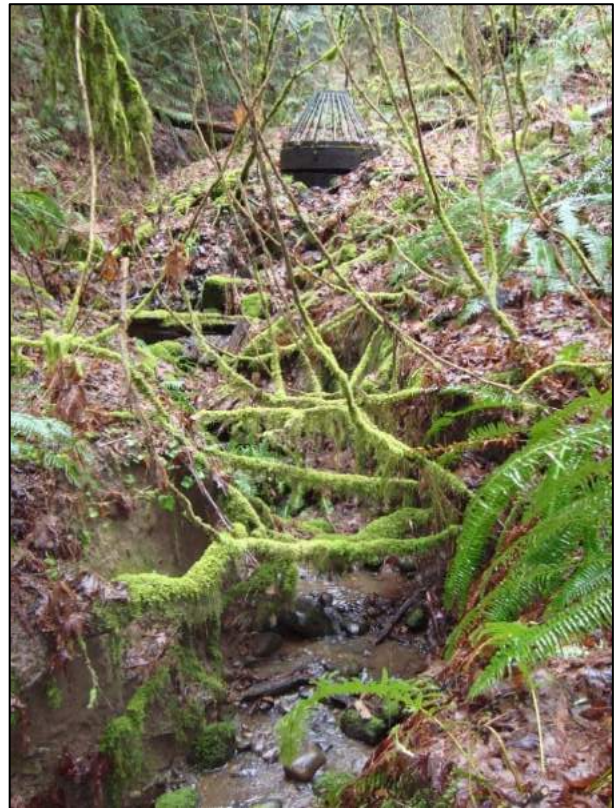
The stream channel in the ravine gets progressively deeper and wider as it moves in the downstream direction. Bed material also coarsens in the downstream direction, transitioning from sand and gravel at the headwaters to cobbles and boulders where additional flow enters the channel in a high-density polyethylene (HDPE) pipe and outlet structure on the left bank. The channel coarsening is likely the result of finer material being eroded away, rather than larger material being deposited. This flow is conveyed from the West Montage neighborhood stormwater vault (described in Section 5.6). Significant erosion was observed around and adjacent to the outlet structure (Photo 5-10).

Photo 5-10. Outfall structure from West Montage vault on south tributary. Looking upstream. Erosion has occurred around outlet structure and within the channel. March 8, 2018.

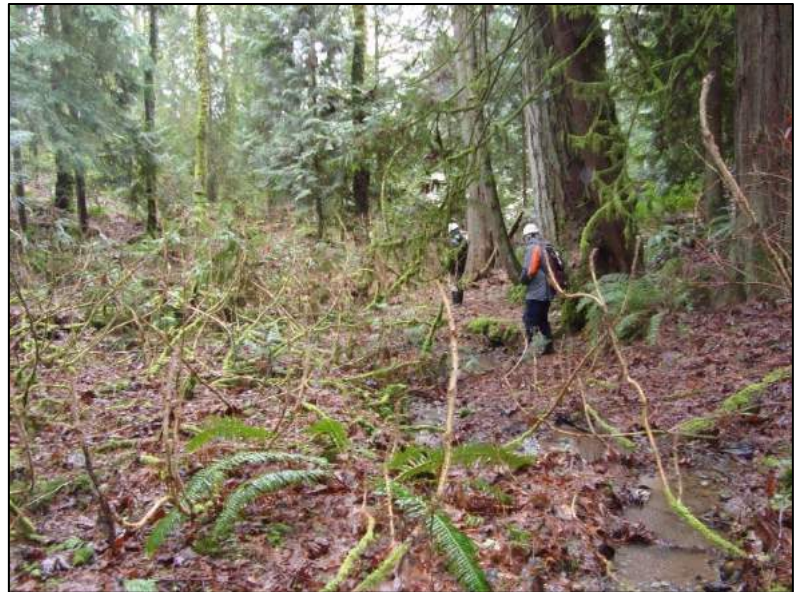
Approximately 50 feet downstream of the outlet structure, the stream gradient flattens, and sediment has been deposited across the ravine bottom (Photo 5-11), with the stream channel cutting a new narrow, deep path through the thick sediment (Photo 5-12). The remaining open channel of the south tributary is incised. The stream enters a birdcage structure upstream of 206th Avenue NE (Photo 5-13) and is conveyed in an 18-inch pipe from the birdcage to another birdcage outlet structure downstream of the 206th Avenue NE culverts on the left bank of the Zackuse mainstem. Figure 5-8 shows a schematic diagram of the stormwater facility at the time of construction at the location where the stream enters the birdcage (Photo 5-13). Sediment has deposited in and around this structure in what was originally a pond. The pipe that originally conveyed flow to the structure has been buried by sediment, and the stream is now discharging over the top of the structure rather than at the bottom as designed.

Photo 5- 11. Depositional area approximately 50 feet downstream of Photo 5-10. Looking downstream. March 8, 2018.

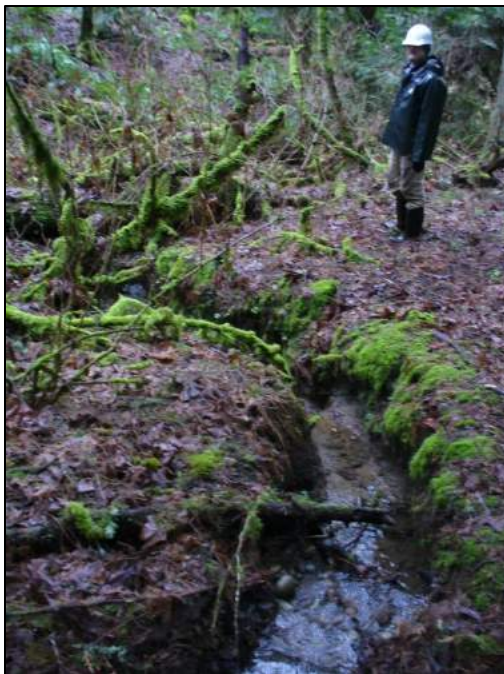
Photo 5-12. Channel incision approximately 100 feet downstream of Photo 5-10. Channel gradient increases and stream has started to incise in sediment shown above in Photo 5-11. Looking upstream. March 8, 2018.

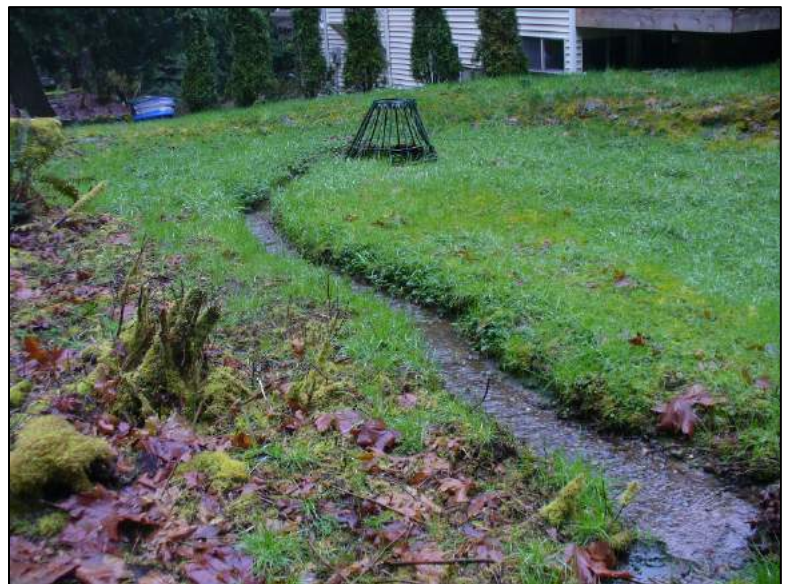
Photo 5- 11. 206th Avenue birdcage structure at the south tributary open channel terminus. 18-inch pipe is buried (see Figure 5-8 for diagram of facility at time of construction). Photo looking to the northwest. March 8, 2018.

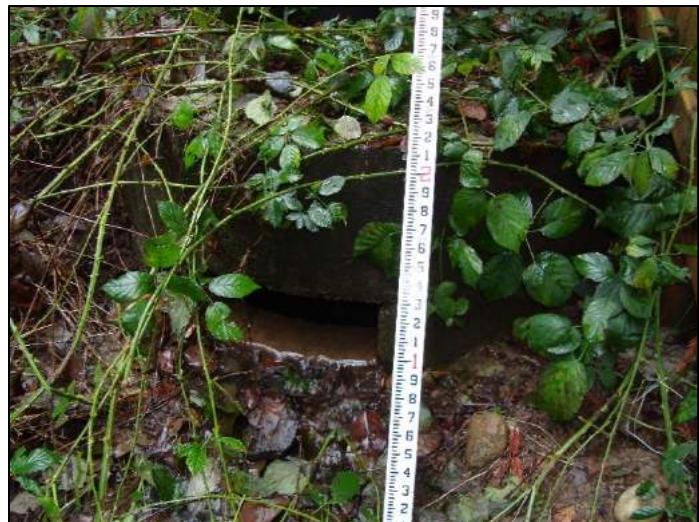
A channel has formed in the ravine between 208th Ave NE and 205th Ave NE in the Tamarack neighborhood. A stormwater outfall at the head of the ravine (Photo 5-14) discharges water from the upstream neighborhood to this location. As a result, the channel conveys stormwater through this area (Photo 5-15).

Photo 5-12. Tamarack outlet structure at top of Tamarack Ravine. January 12, 2018.

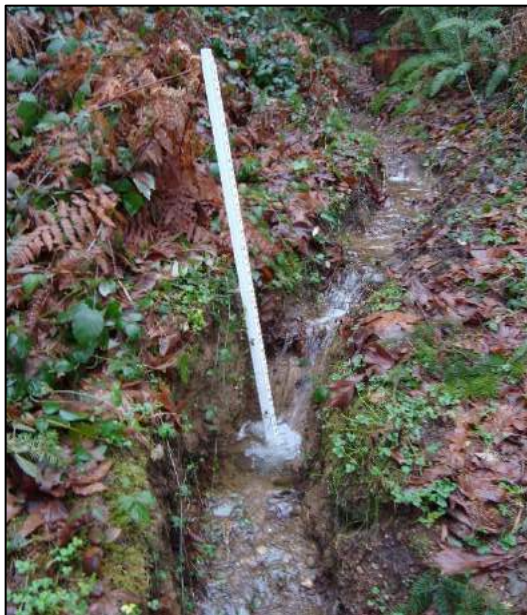
Photo 5-13. Channel forming in Tamarack Ravine. Photo looking east. January 12, 2018.

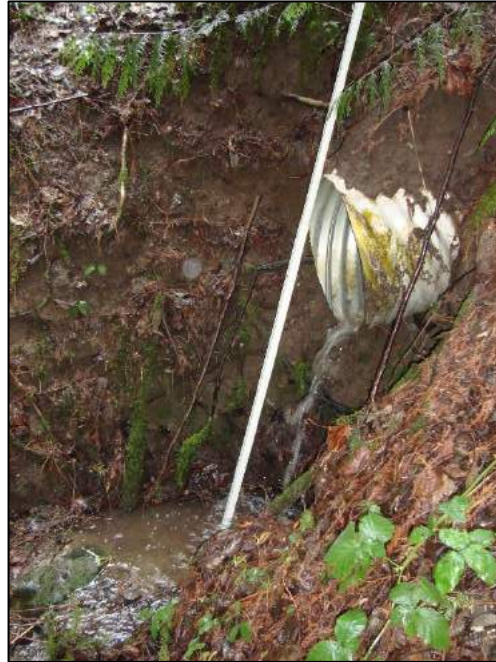
Photo 5-14. Perched culvert on private driveway south of Louis Thompson Road NE, near 210th Avenue NE. Looking upstream toward the north. March 8, 2018.

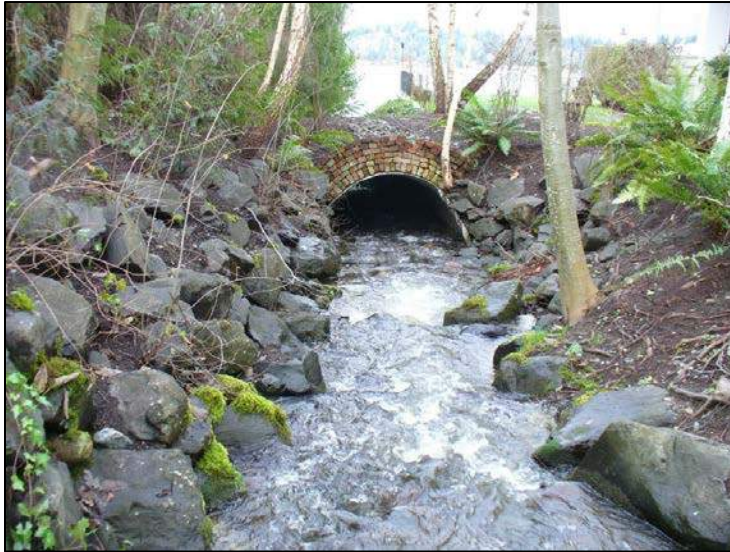
Photo 5-14. One of two 6-foot-diameter culverts along Zackuse Creek approaching the mouth. Lake Sammamish is in the background. This culvert and the other culvert (not shown) may be hindrances to fish movement but are not significant barriers. January 12, 2018.

The two lower-most potential barriers are on private property and are shown on the SalmonScope website (WDFW 2018b) as unknown blockages. These consist of 6-foot-diameter corrugated metal half-pipe (CMP) culverts, one of which is shown in Photo 5-14. Based on evaluations included as part of this plan, these may be considered hindrances to fish movement but not barriers.

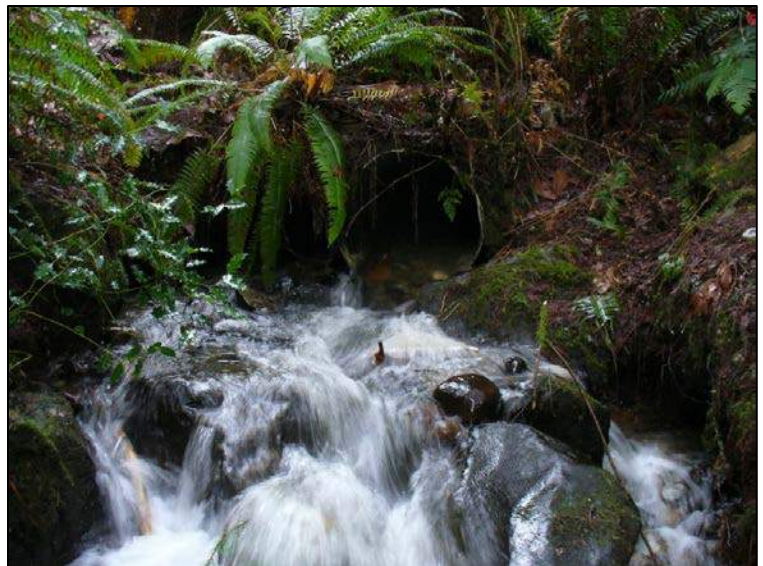
Photo 5-15. Twin 24-inch-diameter CMP culverts at 206th Avenue NE are considered a partial fish passage barrier. Photo is looking upstream toward the east. January 12, 2018.

The remaining partial (but substantial) man-made barrier along Zackuse Creek occurs at the 206th Avenue NE crossing. This crossing is shown in Photo 5-15.

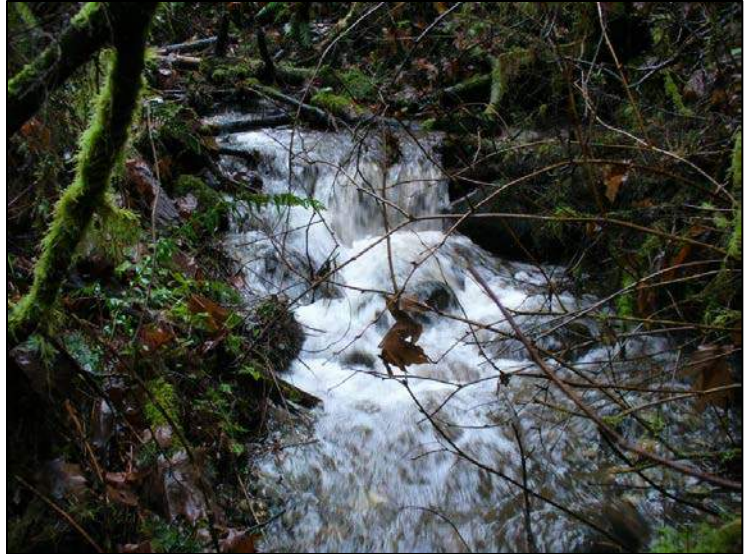
Photo 5-16. Cascade in upper Zackuse Creek reach. January 12, 2018.

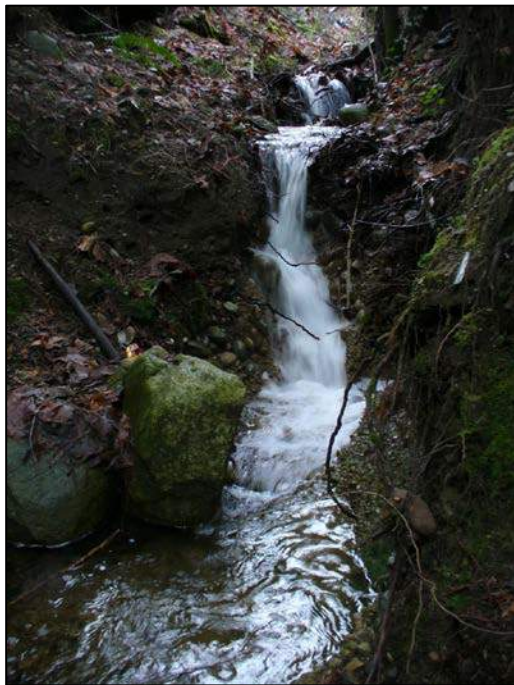
Photo 5-16. Low falls in Upper Zackuse Creek reach in steep ravine. January 12, 2018.

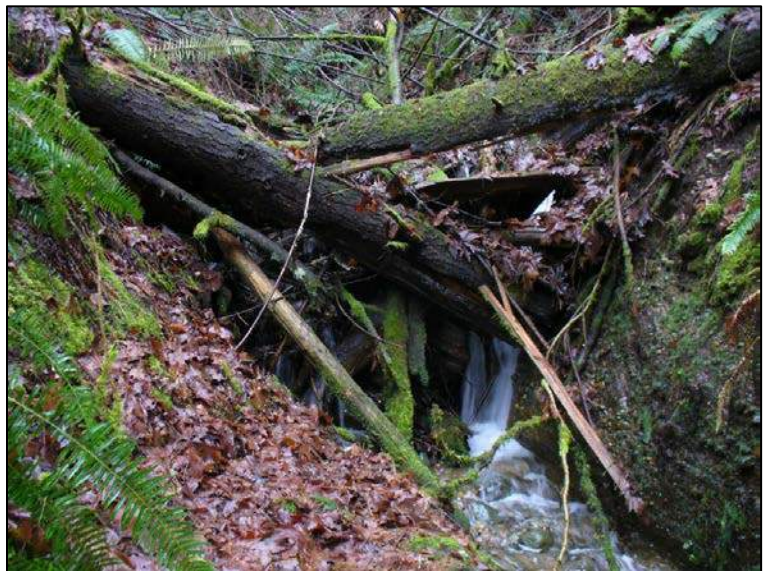
Photo 5-15. High debris jam in the Upper Zackuse Creek reach in the steep ravine. January 12, 2018.

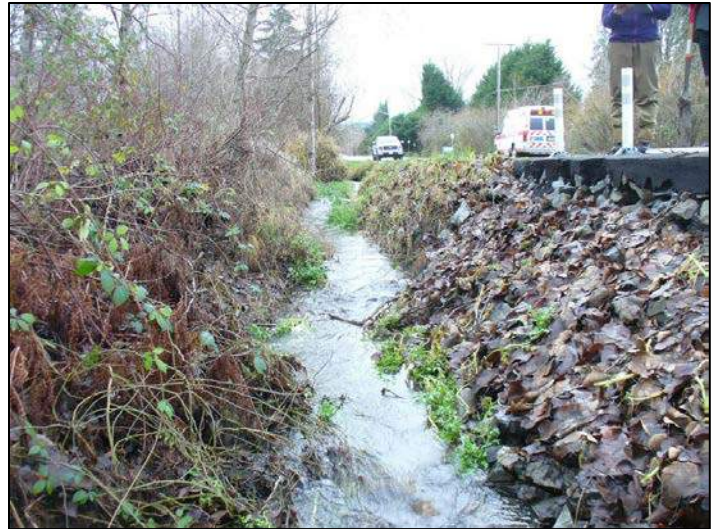
Photo 5-17. Zackuse Creek flowing in ditch along E Lake Sammamish Parkway prior to late summer 2018, when the creek was realigned away from the road. Photo is looking to the south. January 12, 2018.

The area extending upstream from E Lake Sammamish Parkway is an extensive wetland area. Water gathered against the east side of E Lake Sammamish Parkway and then flowed northward in a ditch-like channel (Photo 5-19) to the former culvert crossing. Channel relocation and enhancements associated with the culvert replacement during late summer 2018 moved this flow away from the roadway and routed it through extensive shrubby wetland areas instead.

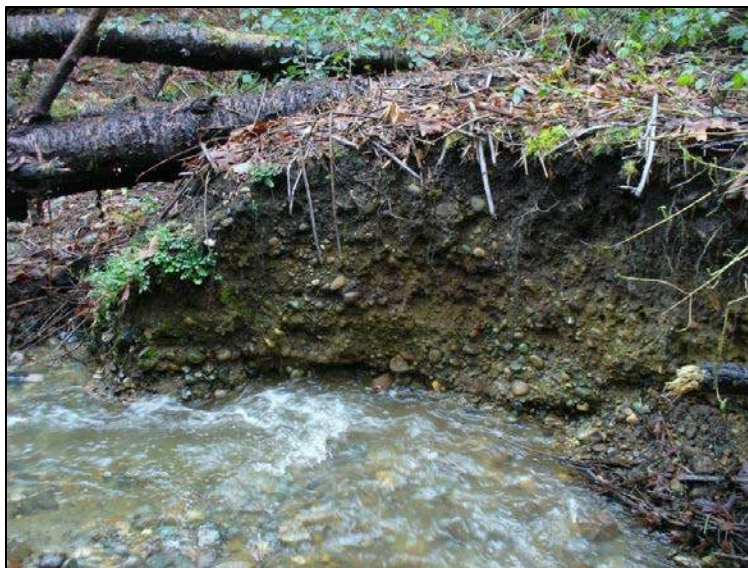
Photo 5-18. Channel downcutting through what appears to be landslide deposits in lower reach. January 12, 2018.

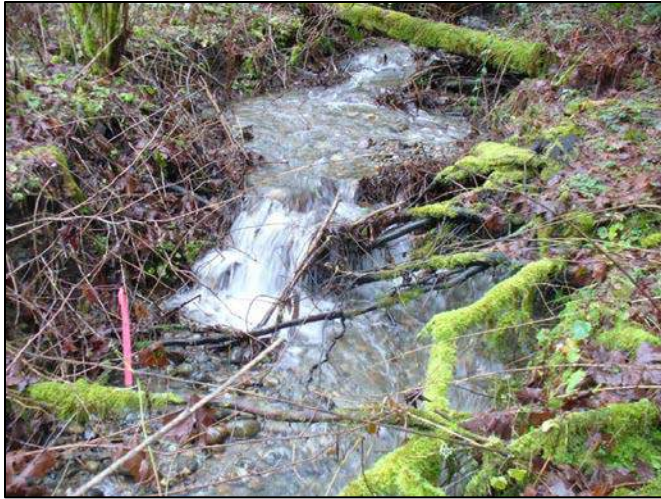
Photo 5-20. Lower reach includes several moderate plunges that could hinder coho or cutthroat passage and may be problematic for kokanee.

Evidence of past debris flow or landslide activity is present along the lower portion. This evidence includes apparent channel movement; snags of cedar trees, which may have been killed by deposition around them; and channel downcutting through what appeared to be landslide or debris flow sediment (Photo 5-20).

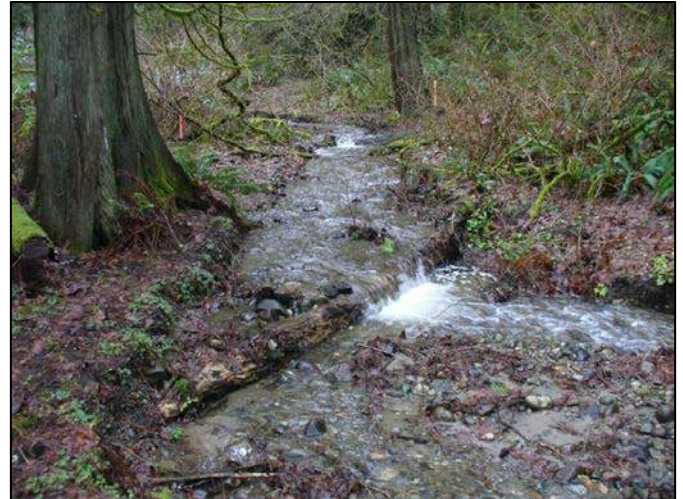
Photo 5-19. Channel incision lessens upstream of Photo 5-21, toward 206th Avenue NE. January 12, 2018.

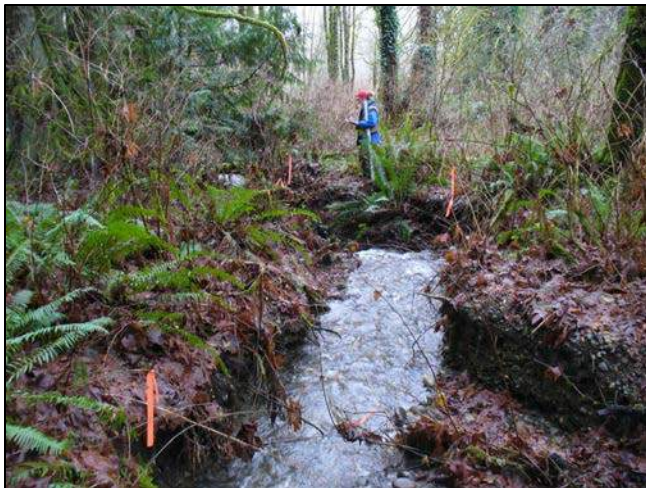
Photo 5-21. Zackuse Creek channel near the dogleg, upstream of channel restoration area. Note overall forested condition, incised channel, and non-native English ivy on the trees in the background. January 12, 2018.

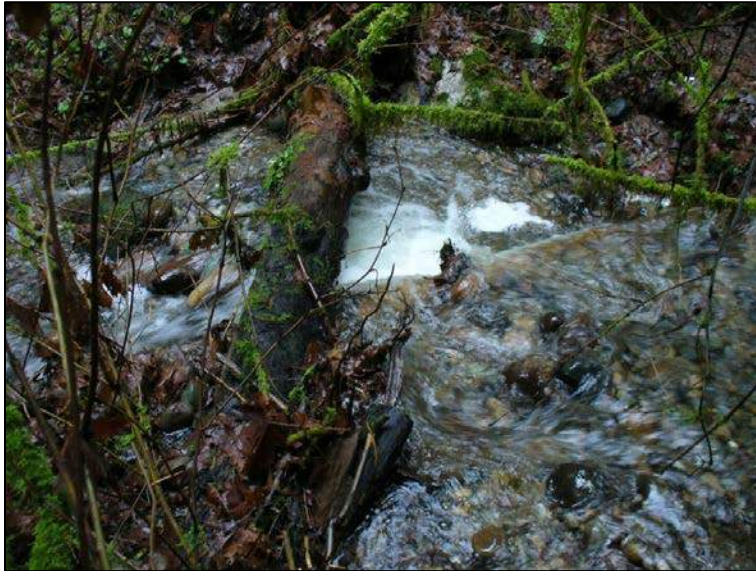
Several instances of ravine side slope instability were described in Section 5.4. More wood is present in the channel than farther downstream (Photo 5-23); however, pools are not well formed due to the

Photo 5-224. Large wood in channel in steep ravine upstream of 206th Avenue NE. January 12, 2018.

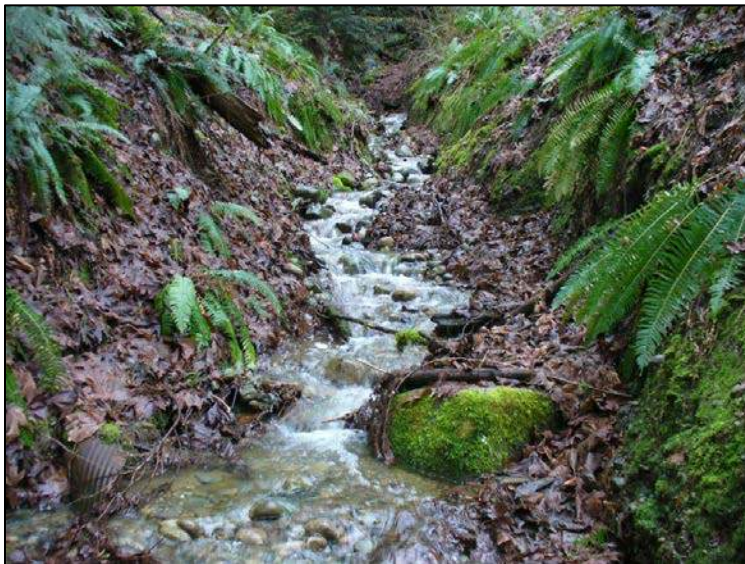
steeper slope and larger substrate materials. Along with the steeper channel, the substrate becomes dominated by rounded cobbles and also includes rounded boulders (Photo 5-24). This stream section includes moderate plunges (See Photos 5-16 and 5-17) and a few large, blocking debris jams (Photo 5-25). This stream section is anticipated to be used by cutthroat trout, more than coho or kokanee because cutthroat trout can spend their entire lives in the stream and do not have to pass through the culvert at 206th Avenue NE to access this part of the stream.

Photo 5-23. Typical channel section showing cobbles and cascade in ravine upstream of 206th Avenue NE. January 12, 2018.

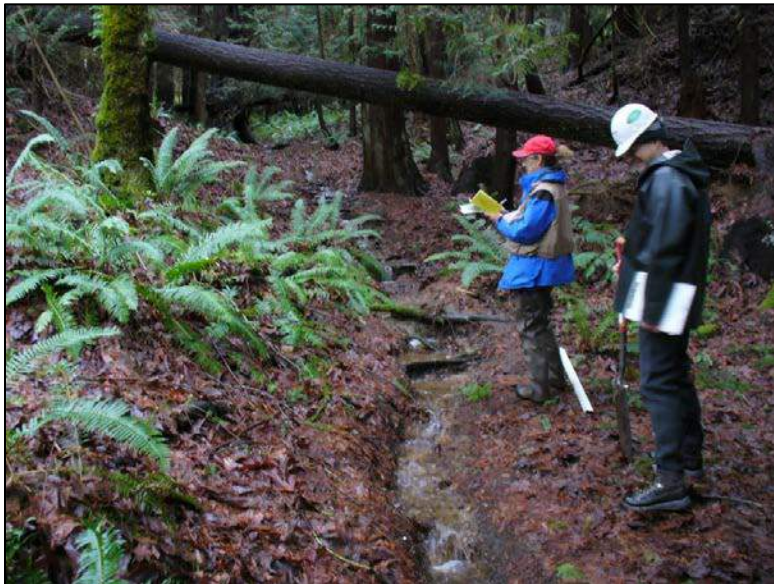
Photo 5-246. Recently forming channel in Tamarack Ravine. Note tree roots crossing the channel that would not likely have grown there had the channel been active when they grew (indicating recent channel development). January 12, 2018.

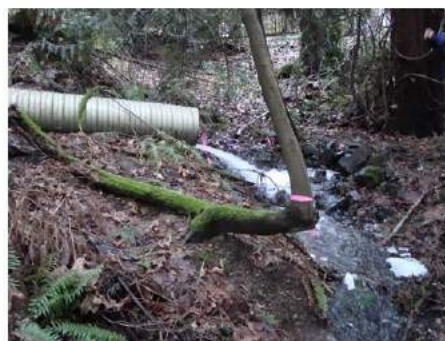
Beginning of Zackuse Creek open channel at Louis Thompson Rd. culvert

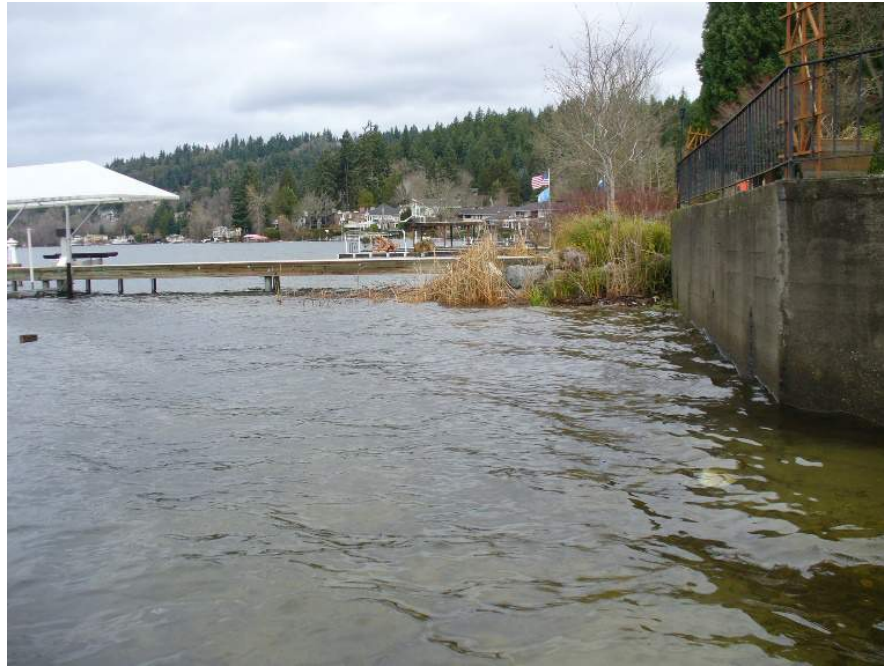
Photo number: Z-1

Site location: Mouth of Zackuse Creek at Lake Sammamish

Description: Looking North

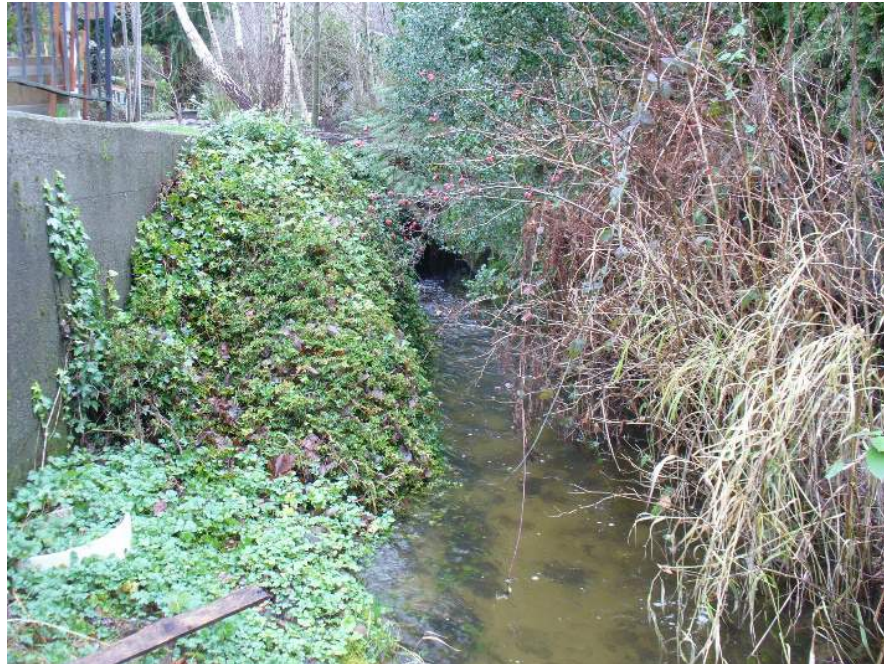
Photo number: Z-2

Site location: ~10' upstream of mouth

Description: Looking upstream from mouth to the east

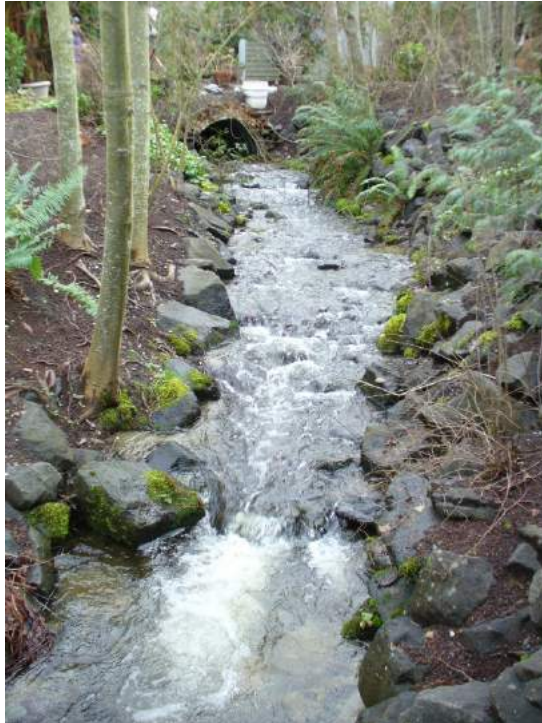
Photo number: Z-3

Site location: 100' upstream of mouth

Description: Looking upstream at second culvert from mouth (photo taken from first culvert)

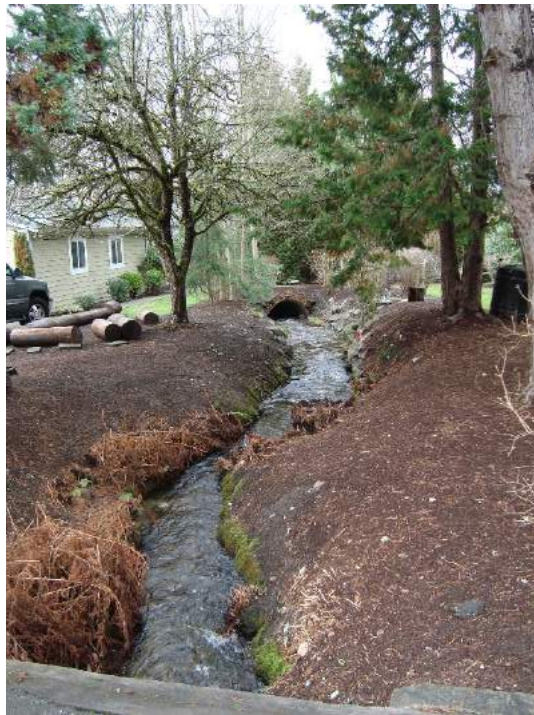
Photo number: Z-4

Site location: 200' upstream of mouth

Description: Looking downstream from Shore Lane at second culvert (from mouth)

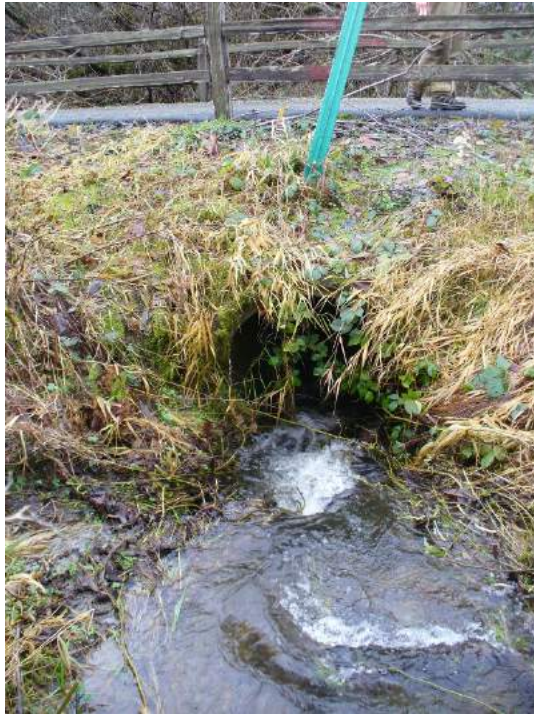
Photo number: Z-5

Site location: 400' upstream of mouth

Description: Looking downstream (west) from East Lake Sammamish Parkway at trail culvert

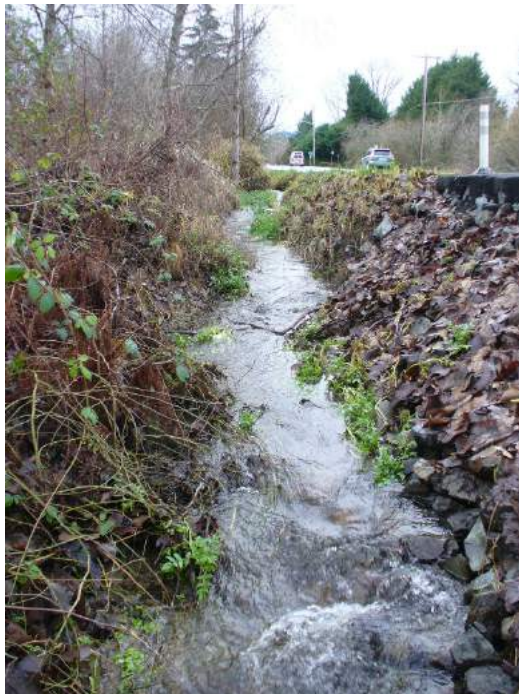
Photo number: Z-6

Site location: 450' upstream of mouth

Description: Upstream side of East Lake Sammamish Parkway, looking south. Stream is flowing north in ditch adjacent to the Parkway (Parkway is on right side of photo)

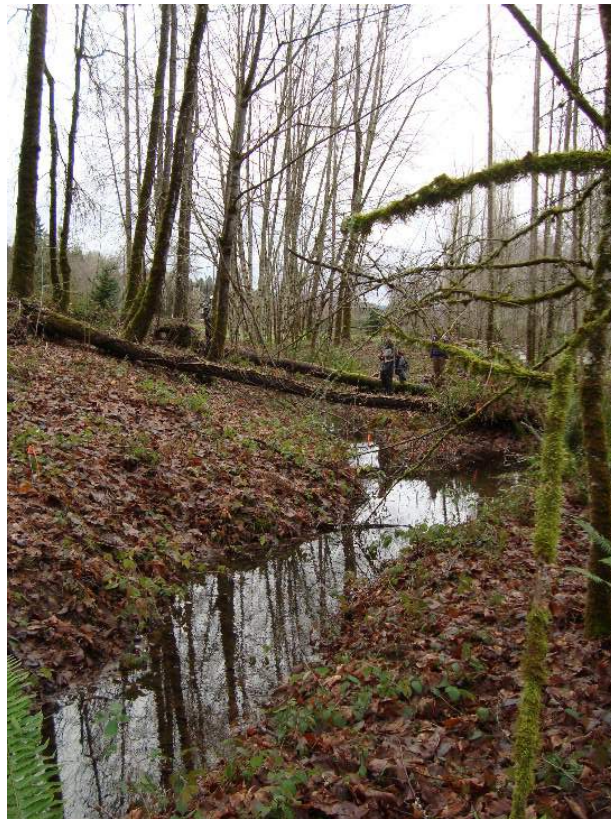
Photo number: Z-7

Description: Looking upstream (east), near upstream end of future restoration project.

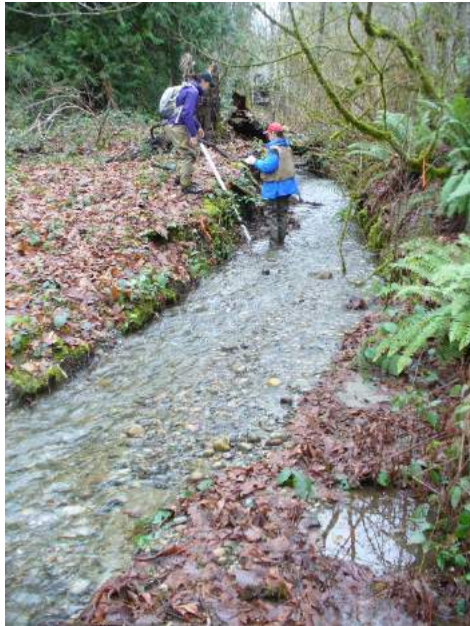
Photo number: Z-8

Description: Looking south at ditch entering channel.

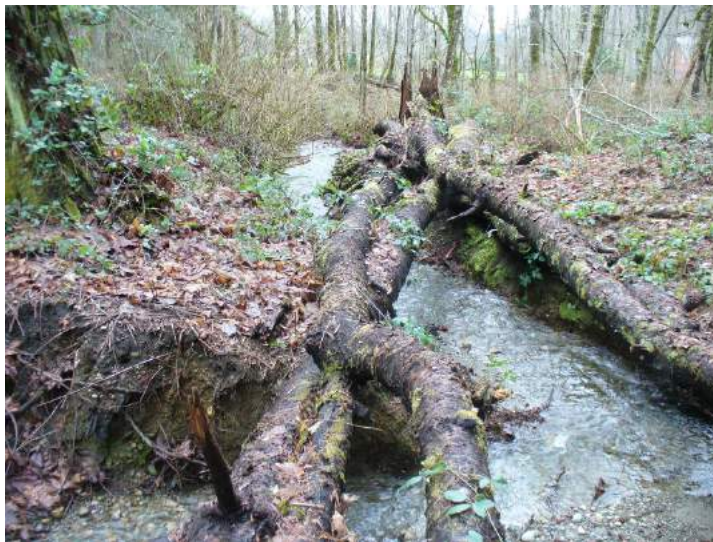
Photo number: Z-9

Description: Looking upstream to the north, in approximate alignment with ditch in photo Z-8. Channel is incised approximately 3 feet, and flow direction turns 90 degrees to the west immediately downstream of this location, and 90 degrees to the east approximately 100' upstream of this location. This is location of dogleg. Sediment deposition appears to block flow, causing shift in channel direction.

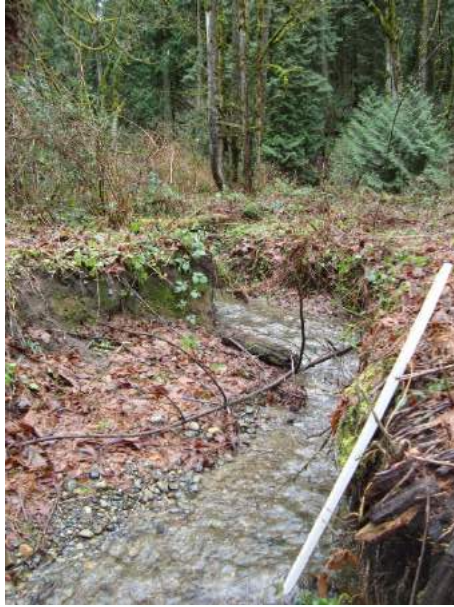
Photo number: Z-10

Description: Looking downstream to the southwest at location of dogleg. Channel is incised through thick sediment deposits.

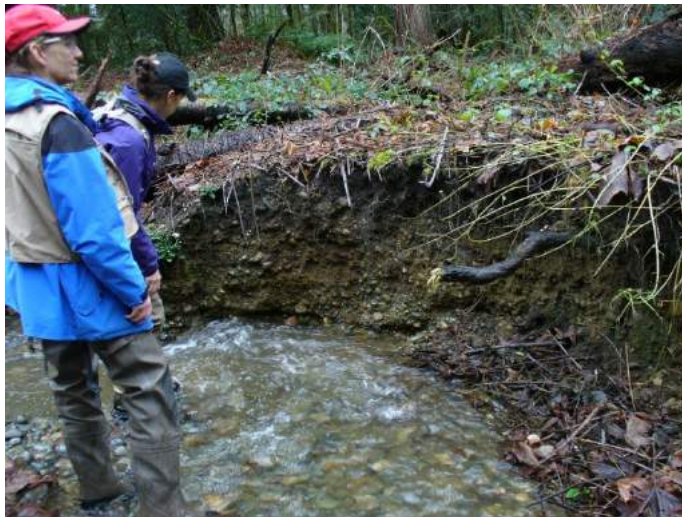
Photo number: Z-11

Description: Looking upstream to the east. Channel is incised approximately 3 feet, and flow direction turns 90 degrees to the south immediately downstream of this location.

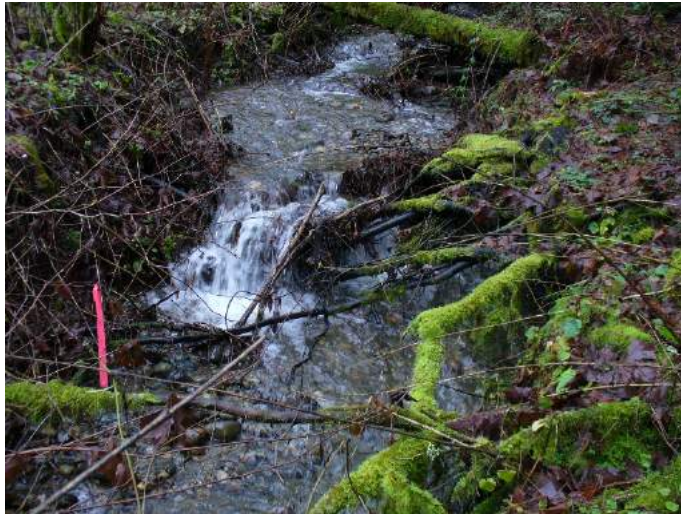
Site location: ~350' downstream of 206th Avenue NE
Photo number: Z-13
Description: Looking downstream where incision in channel is starting.

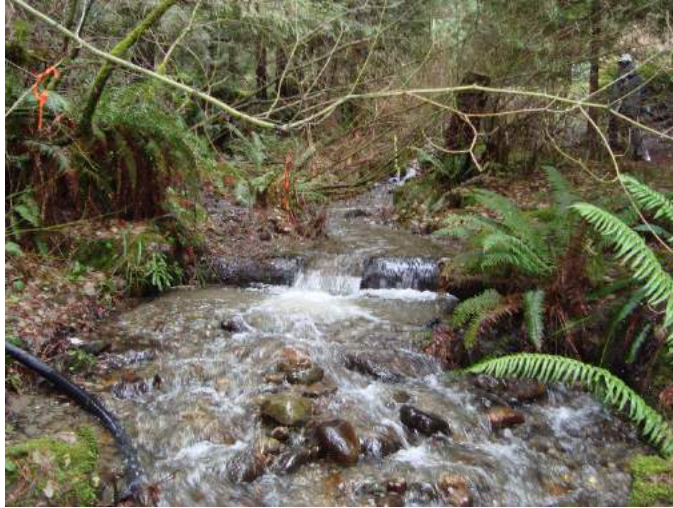
Site location: ~300' downstream of 206th Avenue NE
Photo number: Z-14
Description: Relatively stable, wider stream section.

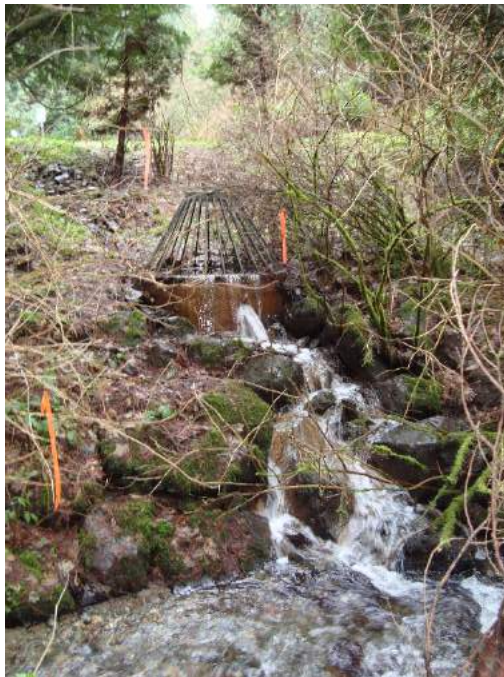
Site location: ~100' downstream of 206th Avenue NE
Photo number: Z-15
Description: Looking upstream (east) at log weir installed by King County (c. late 1990s)

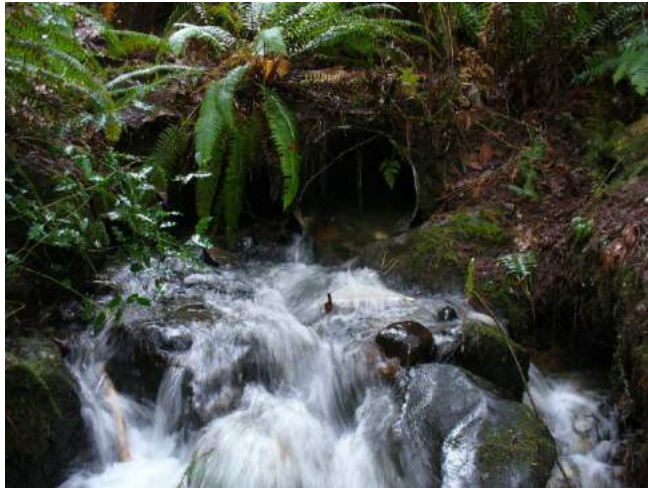
Site location: 206th Avenue NE
Photo number: Z-16
Description: Birdcage structure and energy dissipation for stormwater outfall, conveying discharge from Montage neighborhood

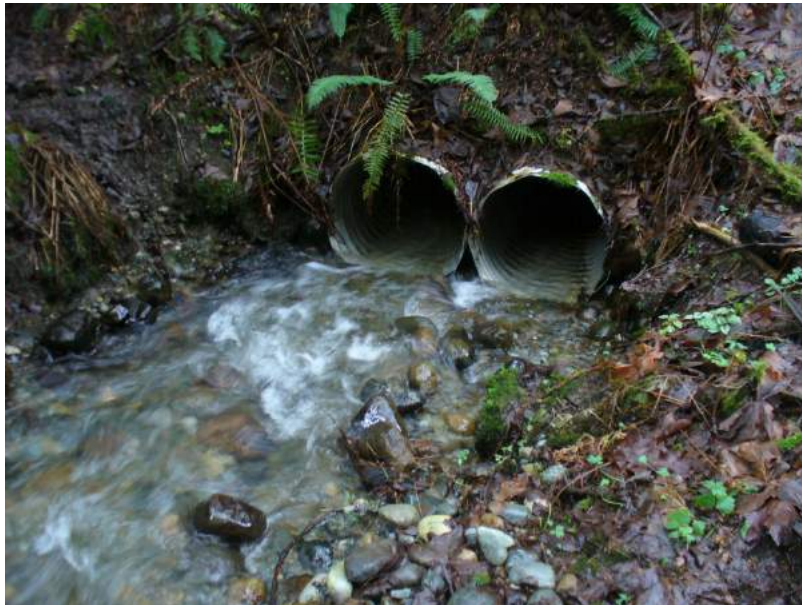
Photo number: Z-17

Description: Looking upstream at twin 24-inch-diameter culverts on downstream side of 206th Avenue NE

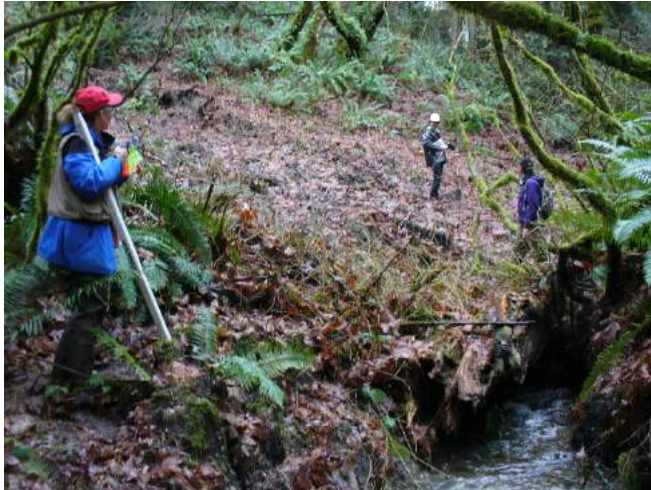
Photo number: Z-19

Description: Looking upstream. Right bank (left side of photo) is very wet (groundwater seepage).
