Final Zackuse Basin Plan

June 7, 2019

OSBORN
CONSULTING
INCORPORATED

THE
WATERSHED
COMPANY

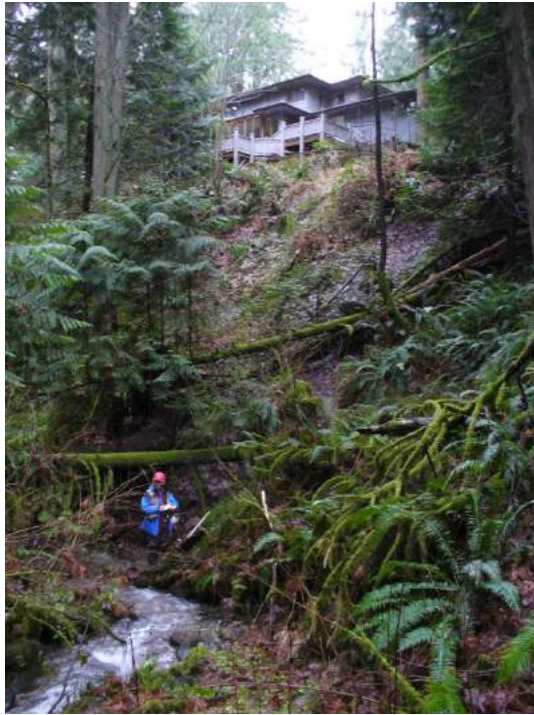
Photo number: Z-20

Description: Looking upstream at right bank hillslope failure (left side of photo) and debris in channel.

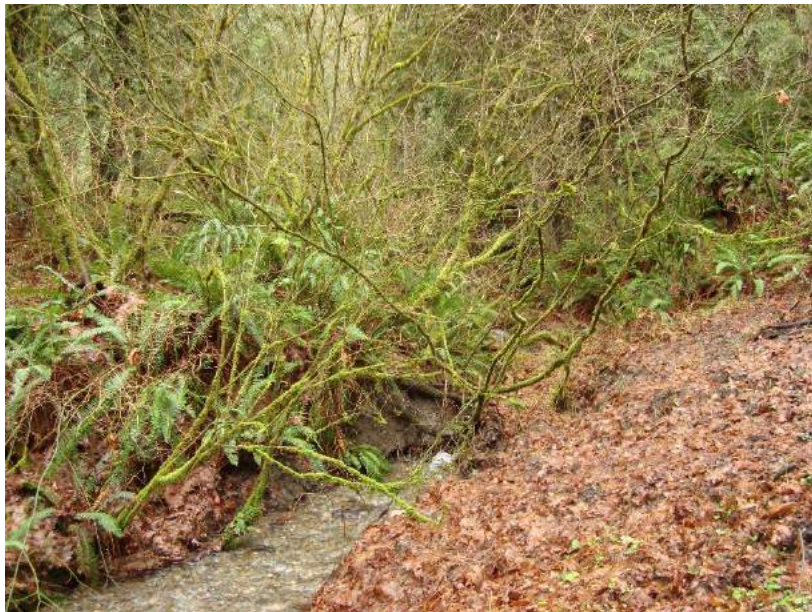
Photo number: Z-21

Description: Right bank hillslope failure (right side of photo).

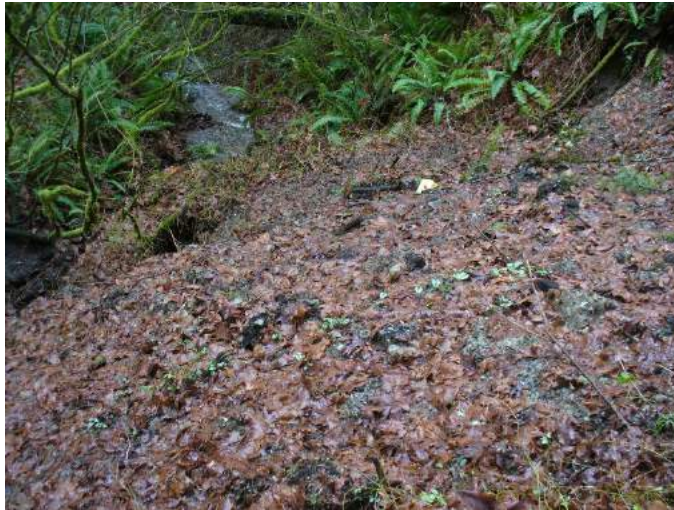
Photo number: Z-22

Description: Looking downstream at hillslope debris (both sides of photo- stream has cut through this material)

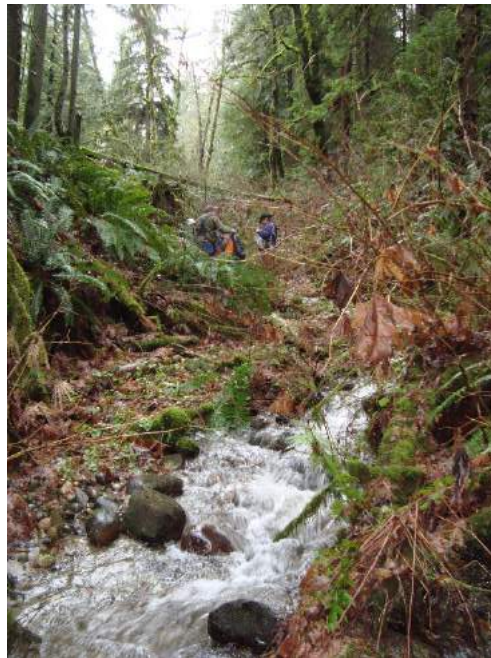
Site location: Same location as Photo Z-20
Photo number: Z-23
Description: Looking downstream direction (toward northwest), at hillslope scarp.

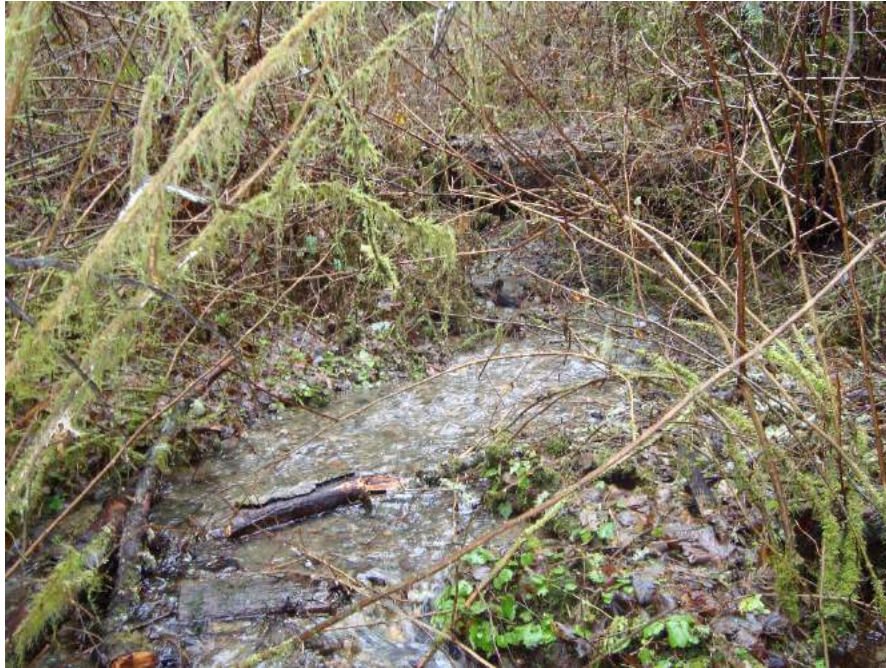
Site location: ~300' upstream of 206th Avenue NE
Photo number: Z-24
Description: Looking upstream at cascade.

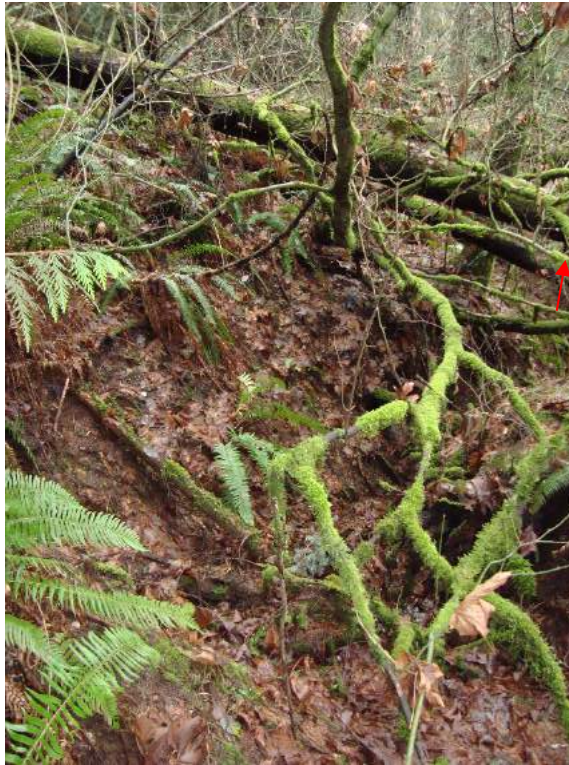
Site location: ~1,200' upstream of 206th Avenue NE
Photo number: Z-27
Description: Looking north at right bank gully. Very wet conditions.

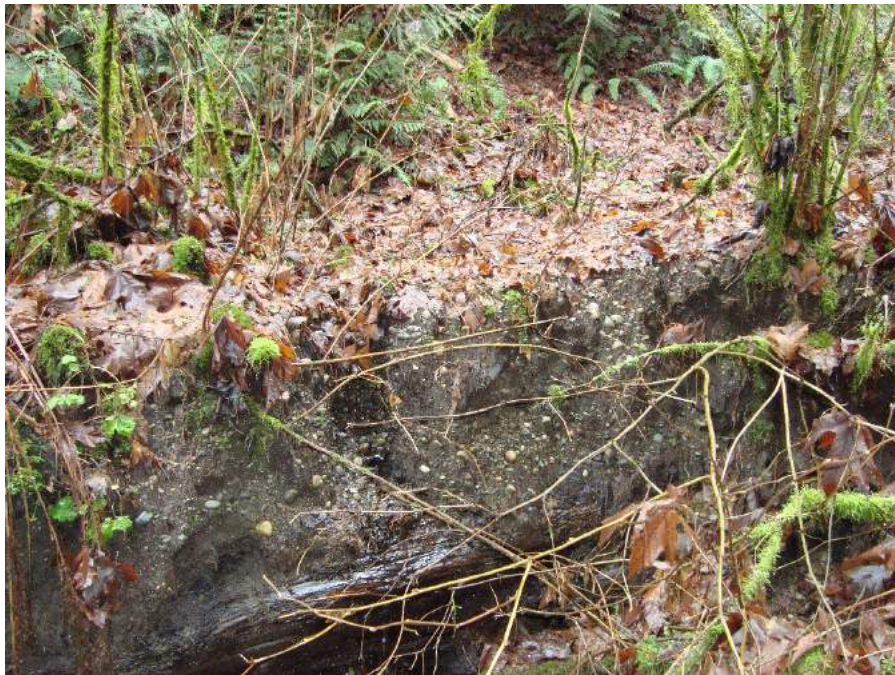
Site location: ~100' upstream of gully mouth with Zackuse Creek
Photo number: Z-28
Description: Looking east at exposed sidewall of gully incised approximately 6 - 10 feet into hillslope.

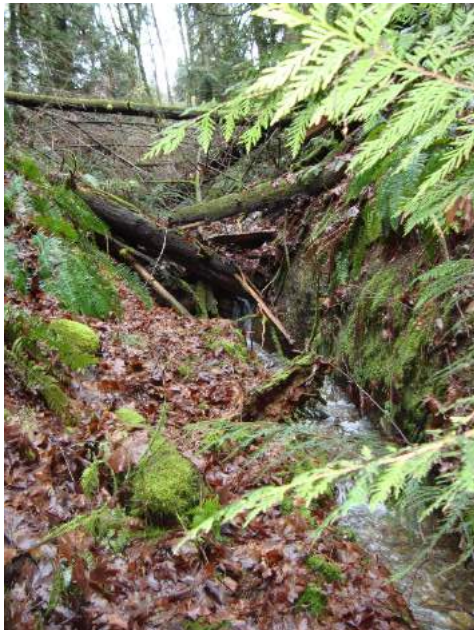
Site location: ~1,200' upstream of 206th Avenue NE
Photo number: Z-29
Description: Looking upstream at cut timber in the channel.

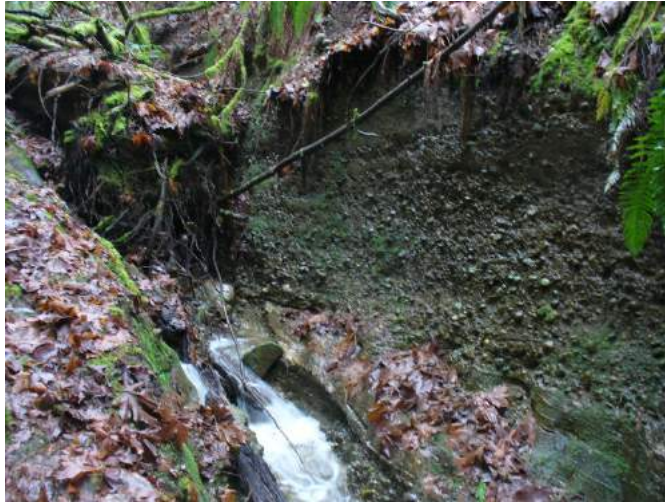
Site location: ~1,275' upstream of 206th Avenue NE
Photo number: Z-30
Description: Looking upstream at debris jam in channel. Lots of downed trees and narrow channel through this reach.

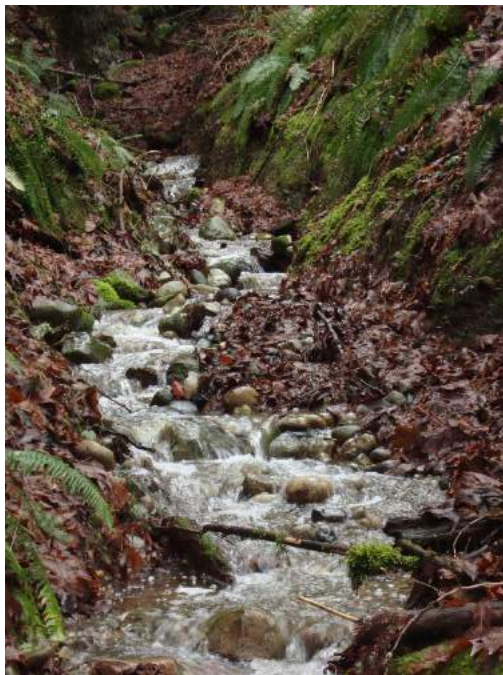
Photo number: Z-31

Description: Looking upstream, geology is more competent in this location.

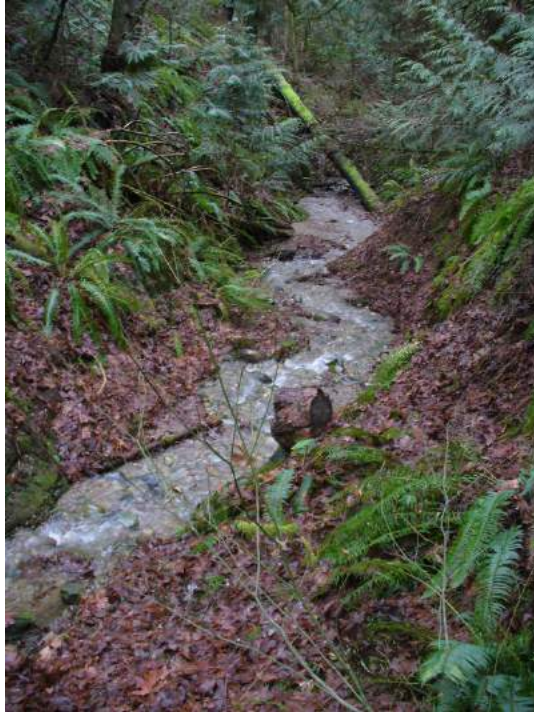
Photo number: Z-32

Description: Looking upstream at boulder cascade.

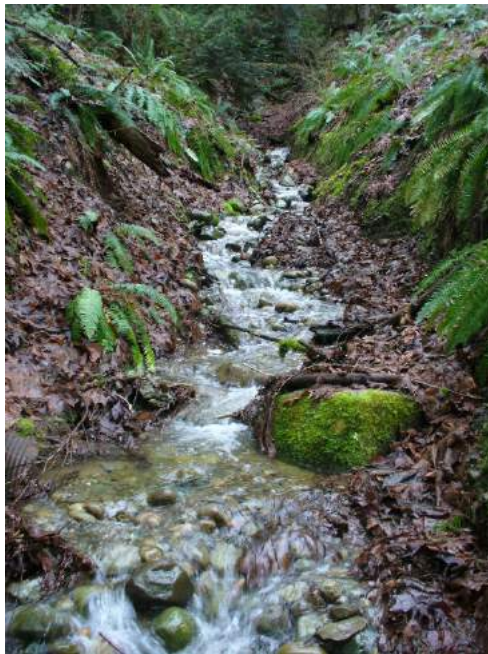
Photo number: Z-33

Description: Looking upstream at channel. Short lower gradient reach between steeper sections.

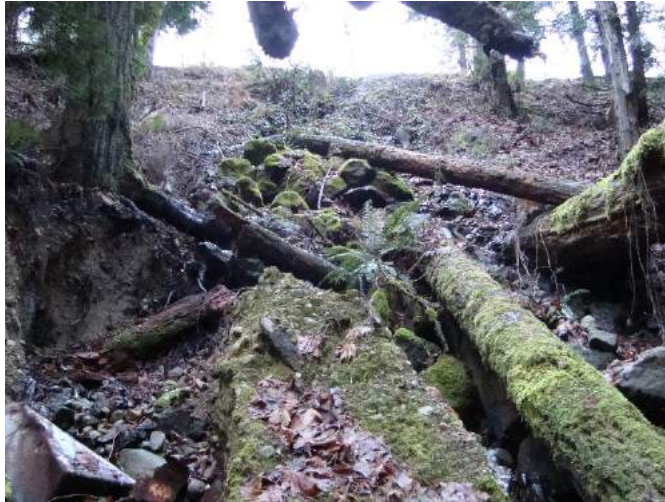
Photo number: Z-34

Description: Looking upstream.

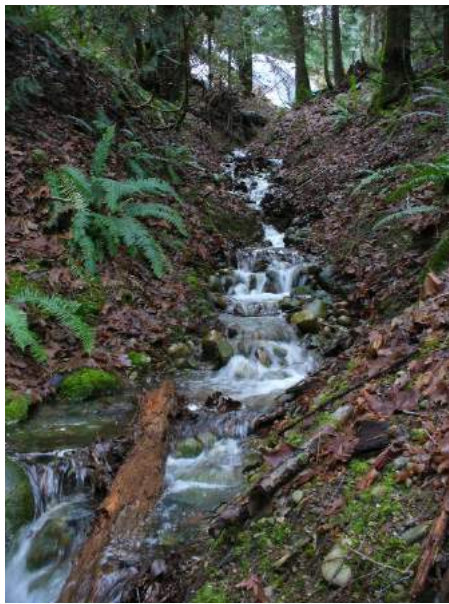
Photo number: Z-35

Description: Looking north up at Louis Thompson Rd. NE at Outfall 4 at the top of photo.

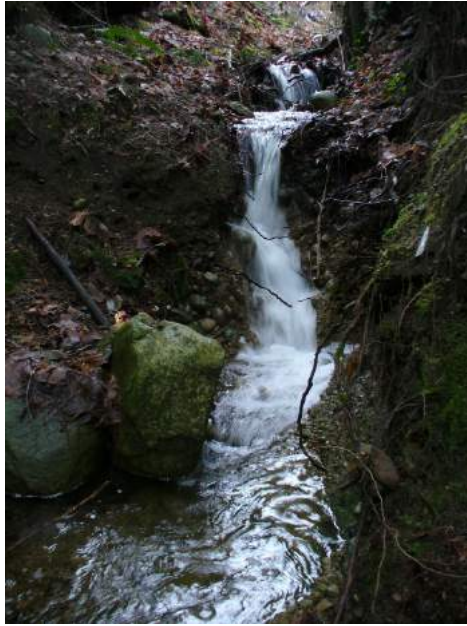
Photo number: Z-36

Description: Looking upstream on the downstream side of right bank slide (top of photo, slide is covered with black plastic) adjacent to Louis Thompson Rd.

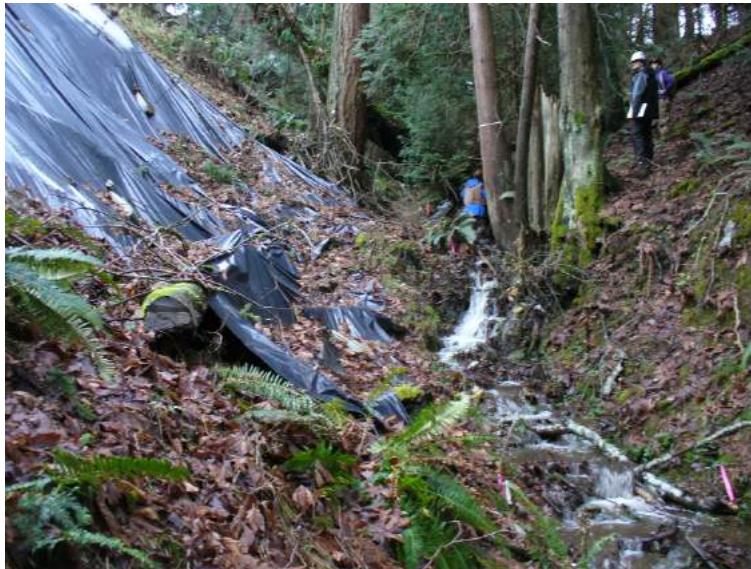
Photo number: Z-37

Description: Looking upstream near right bank slide area, downstream of photo Z-38.

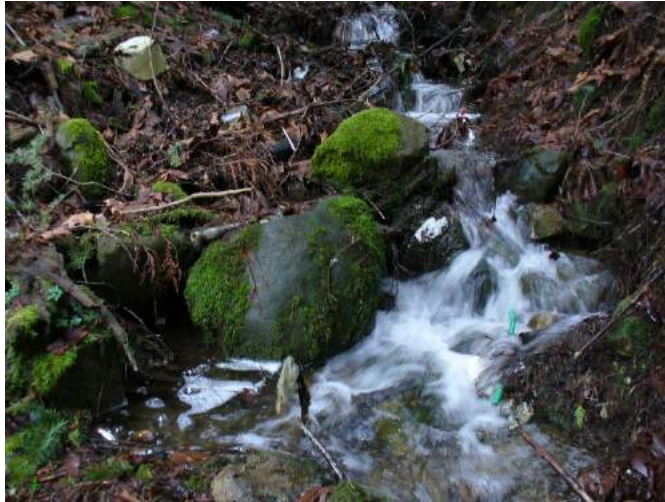
Photo number: Z-38

Description: Slide shown on left side of photo.

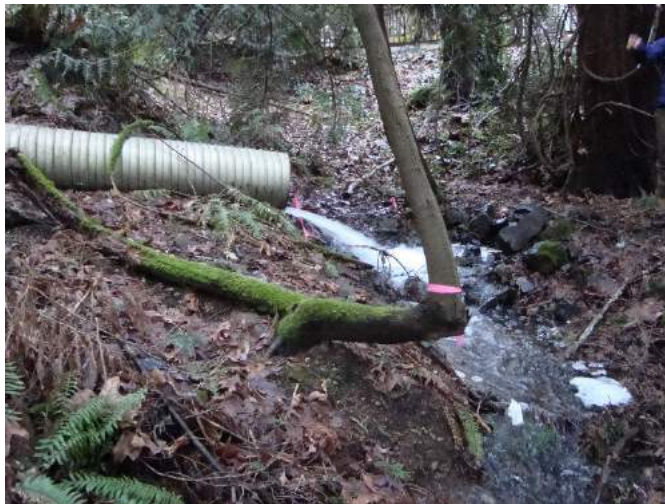
Site location: ~2,000' upstream of 206th Avenue NE
Photo number: Z-39
Description: Looking upstream at debris in channel (near slide).

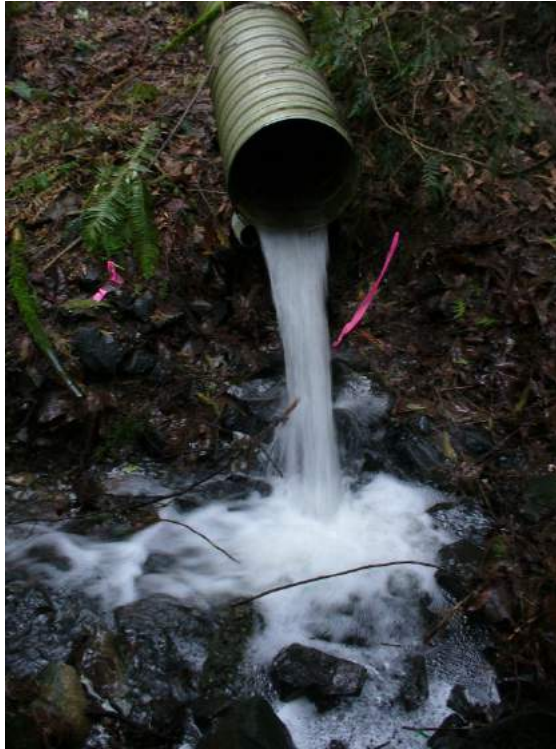
Site location: ~2,100' upstream of 206th Avenue NE
Photo number: Z-40
Description: Looking upstream at culvert (Outfall 5) discharging water to form the headwaters of Zackuse Creek.

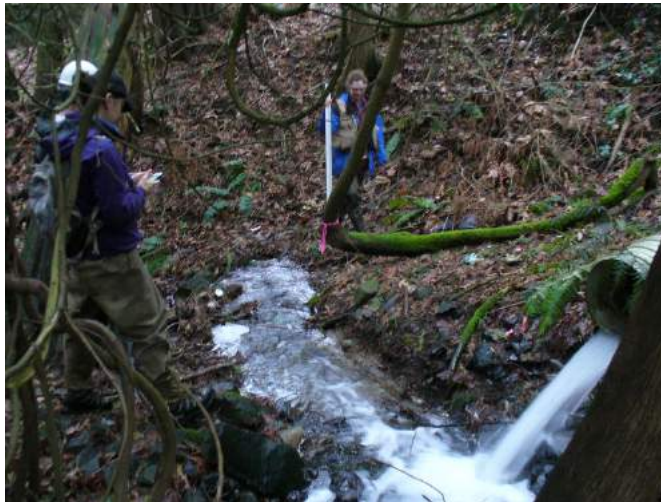
Photo number: Z-41

Description: Close-up of culvert (Outfall 5) discharging water to Zackuse Creek (headwaters).

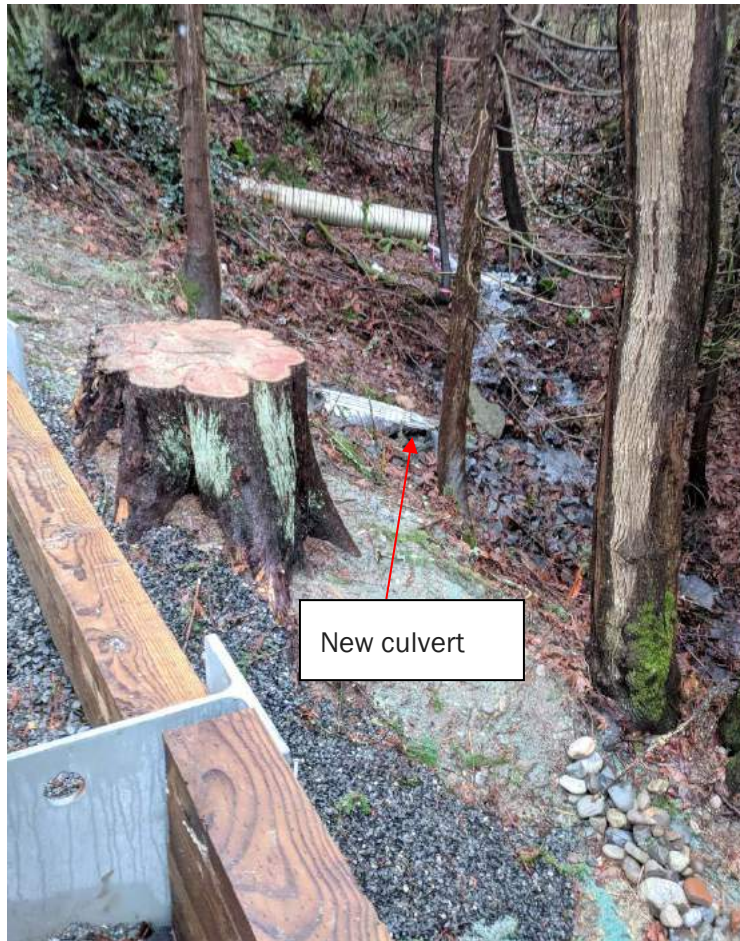
Photo number: Z-42

Description: Looking downstream at culvert discharging water to Zackuse Creek.

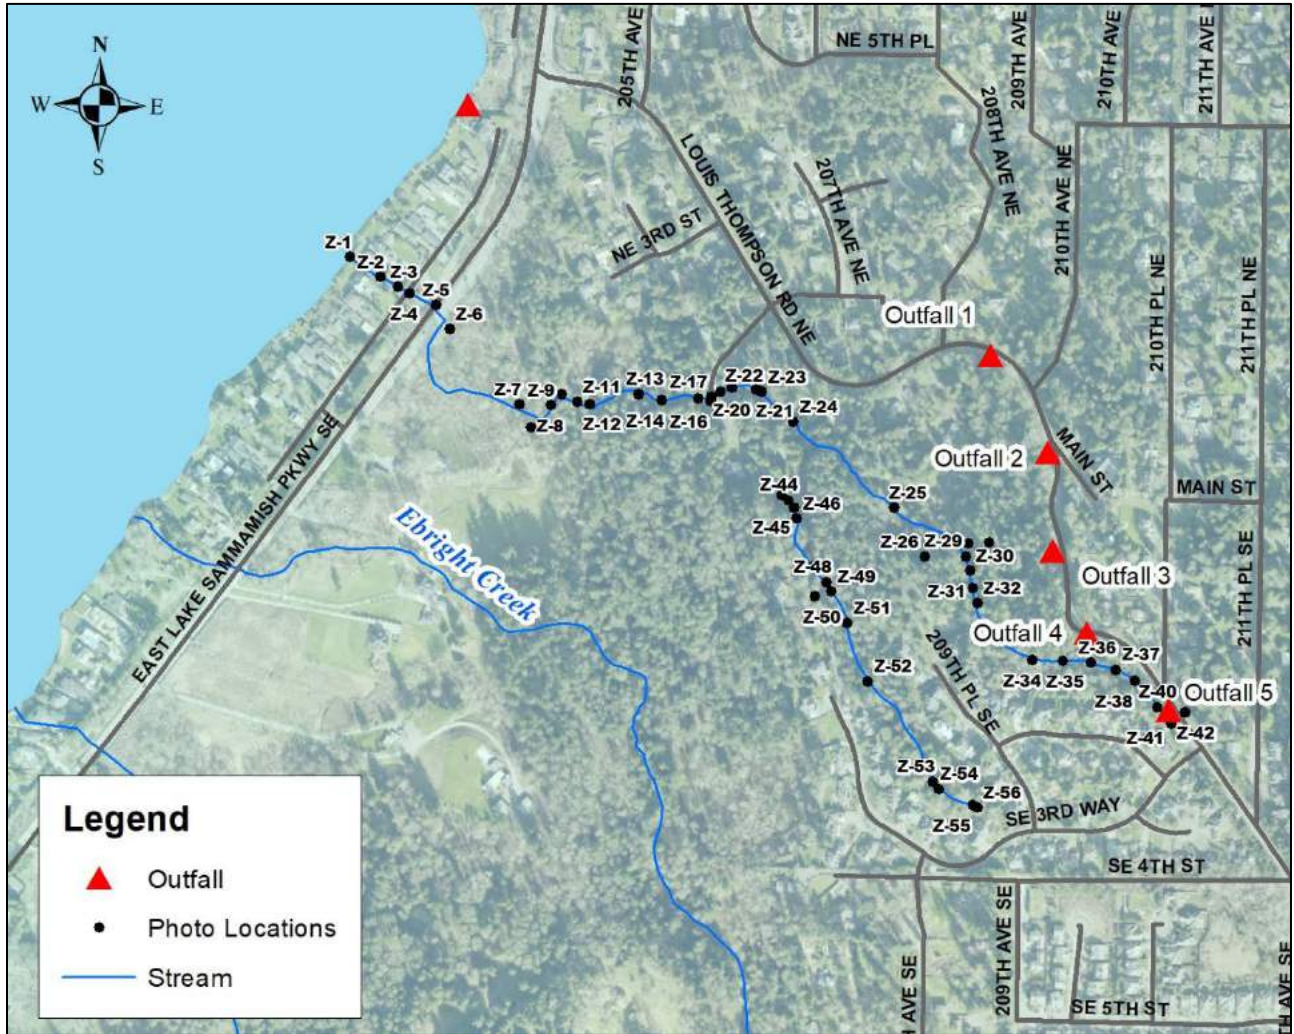
Figure 2. Zackuse Creek South Tributary Photo Location Points

South Tributary Zackuse Creek photo locations are shown in Figure 2. South Tributary Zackuse Creek photos were taken on March 8, 2018.

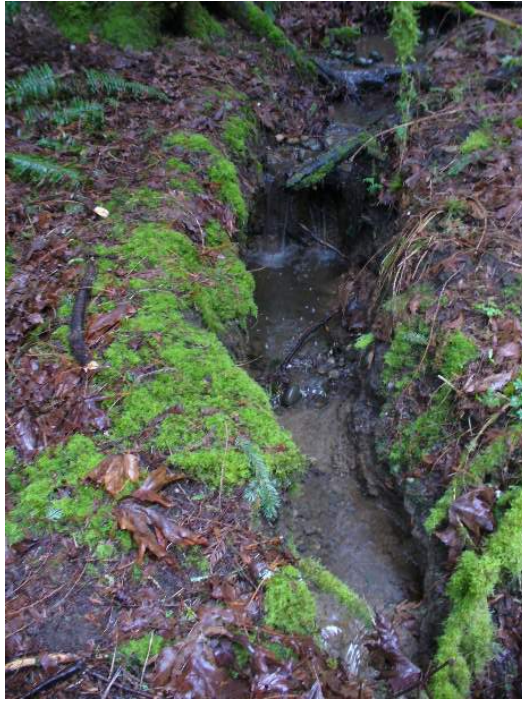
Photo number: Z-44

Description: Looking northwest at birdcage structure. Foreground of photo has been filled in with sediment. Eighteen inch-diameter pipe is buried beneath the sediment.

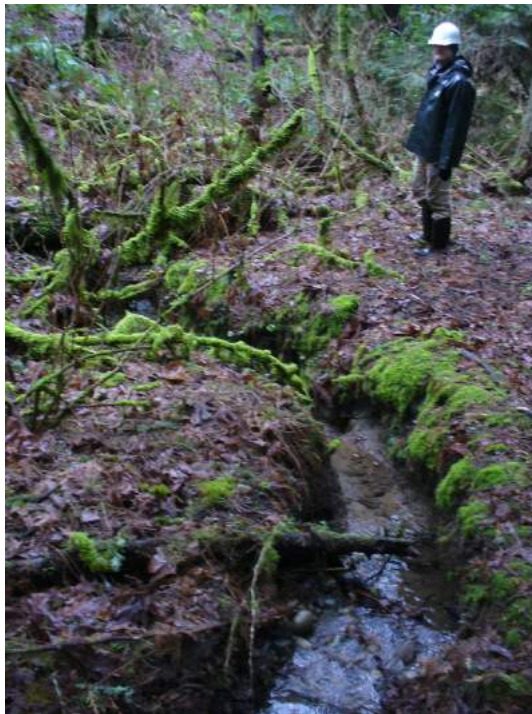
Site location: 100' upstream of birdcage near 206th Ave NE
Photo number: Z-45
Description: Incised channel through deposited sediment.

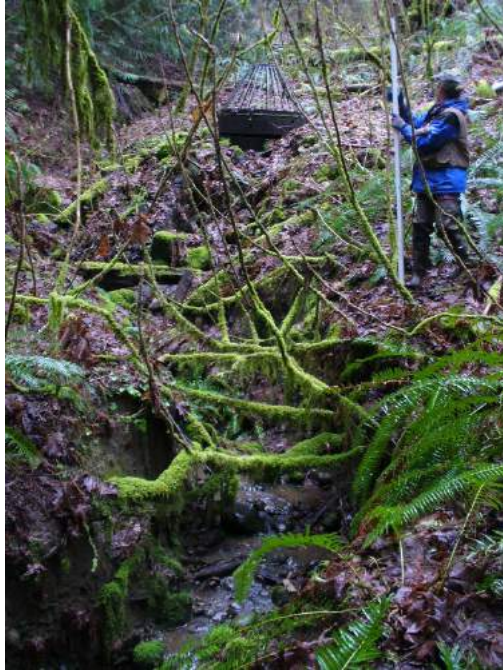
Site location: 150' upstream of birdcage east of 206th Ave NE
Photo number: Z-46
Description: Deeper incision in the upstream direction.

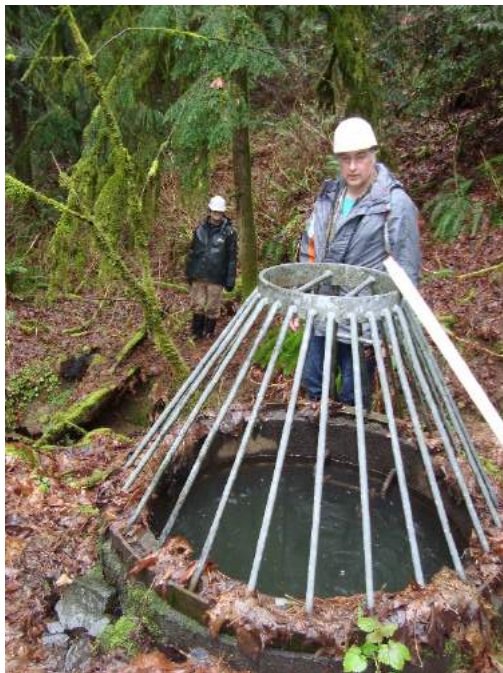
Photo number: Z-47

Description: Looking upstream at incised channel and outlet structure on left bank (middle of photo) from west Montage neighborhood.

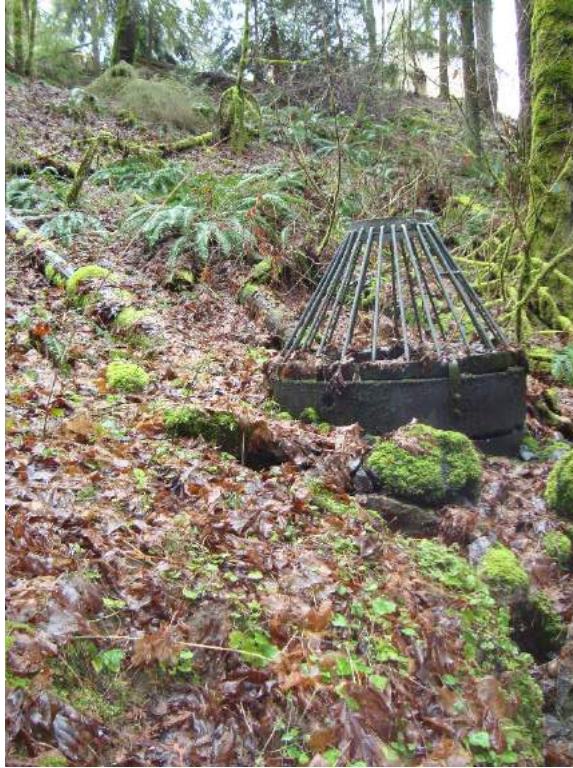
Photo number: Z-48

Description: Upstream side of outlet structure looking to the northeast.

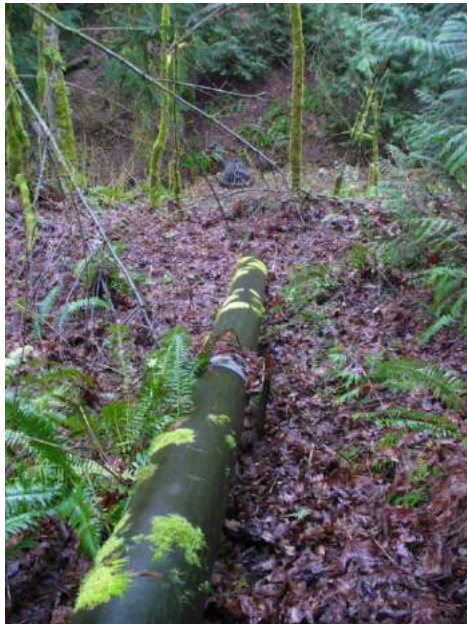
Site location: 400' upstream of birdcage east of 206th Ave NE

Photo number: Z-50

Description: Looking north along HDPE pipe down to stream channel and outlet structure near the top of the photo.

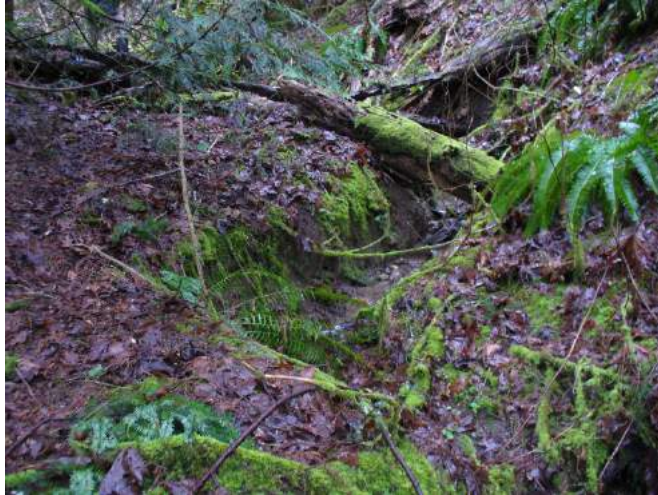
Site location: 450' upstream of birdcage east of 206th Ave NE

Photo number: Z-51

Description: Looking upstream at incised channel.

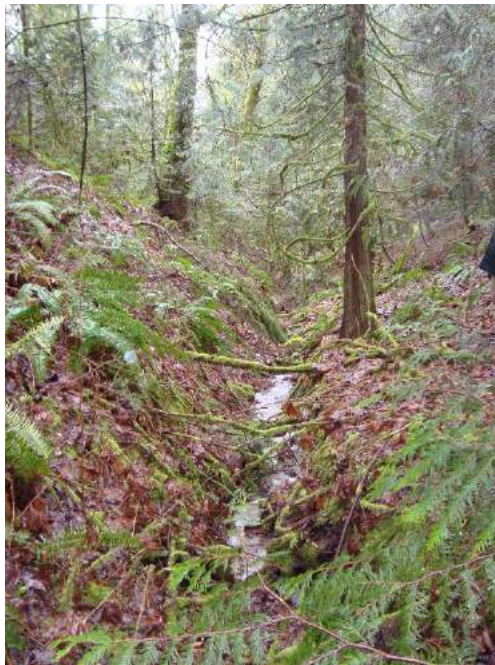
Site location: ~ 750' upstream of birdcage east of 206th Ave NE

Photo number: Z-52

Description: Looking downstream to the west. Channel is slightly incised.

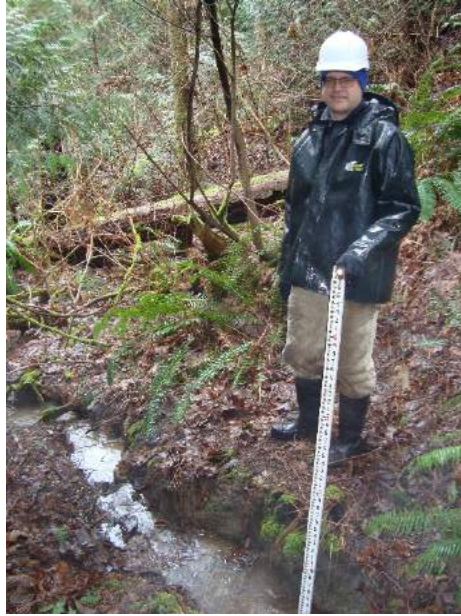
Site location: ~1000' upstream of birdcage east of 206th Ave NE
Photo number: Z-53
Description: Looking downstream at channel where incision is beginning.

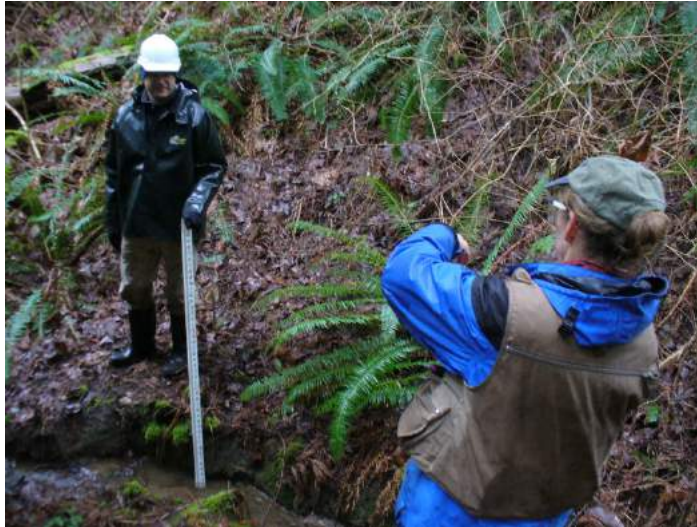
Site location: ~1000' upstream of birdcage east of 206th Ave NE
Photo number: Z-54
Description: Same location as photo Z-53, showing incision.

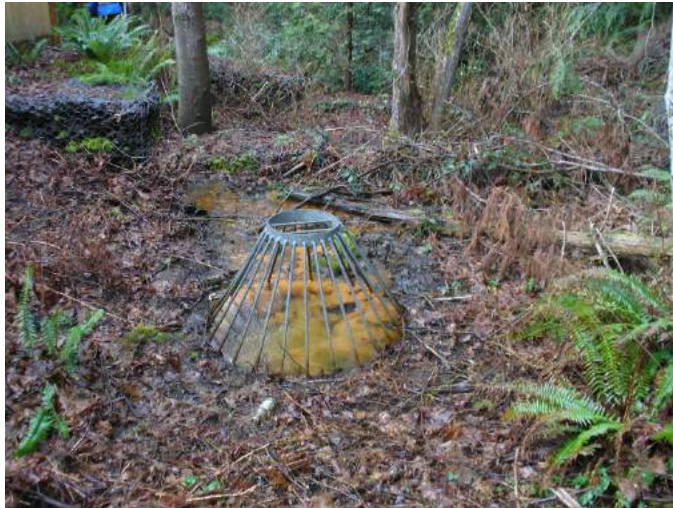
Site location: ~ 1100' upstream of birdcage east of 206th Ave NE
Photo number: Z-55
Description: Looking downstream (west) at birdcage outfall and gabion structures behind it. Location is near SE 3rd Street. Headwaters of S. Tributary.

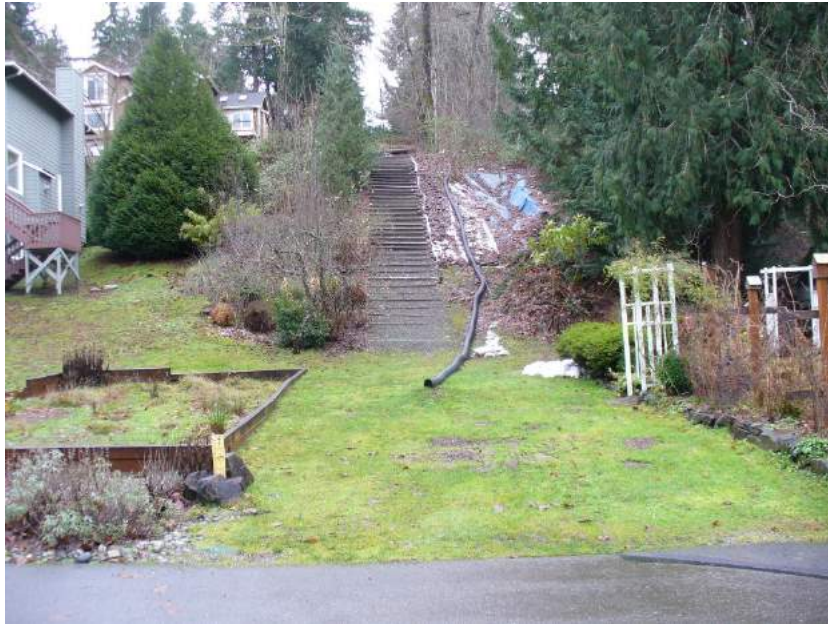
Photo number: Up-1

Site location: Temporary drainage pipe on slope from 209th Ave NE to 208th Ave NE, in alignment with NE 4th Street in Tamarack

Description: Looking East

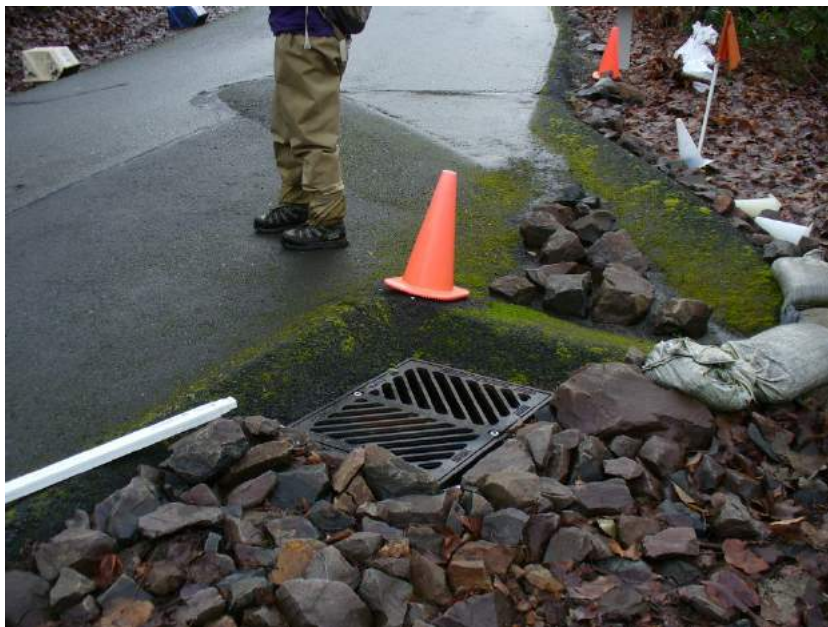
Photo number: Up-2

Site location: 209th Ave NE catch basin and berm that conveys water from private homes on 209th Ave NE. Road runoff is conveyed in temporary storm water pipe.

Description: Looking at catch basin from the north

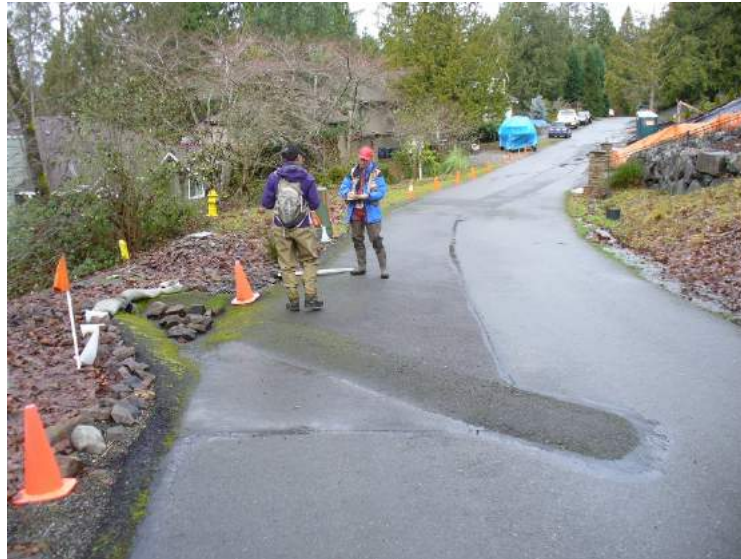
Photo number: Up-3

Site location: Location of catch basin and berm shown in photo Up-2.

Description: Looking north. Berm separates flow from south 209th Ave NE road runoff from private home drainage that flows to catch basin on other side of berm.

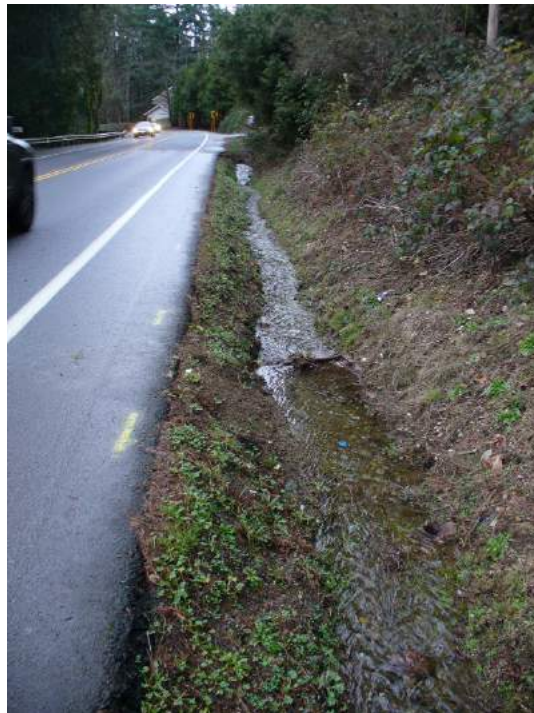
Photo number: Up-4

Site location: Louis Thompson Road upstream of Zackuse Creek headwaters

Description: Looking northwest at east side of road (water in ditch) that flows to Zackuse Creek

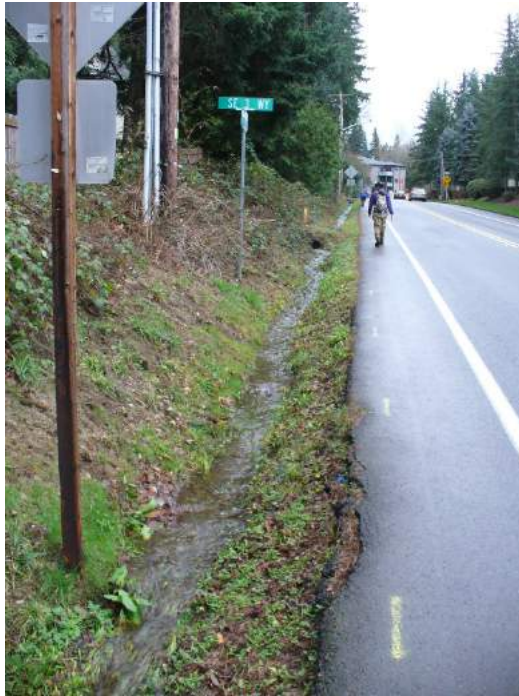
Photo number: Up-5

Site location: 430' upstream of mouth

Description: Upstream side of East Lake Sammamish Parkway, looking south. Stream is flowing north in ditch adjacent to the Parkway (Parkway is on right side of photo)

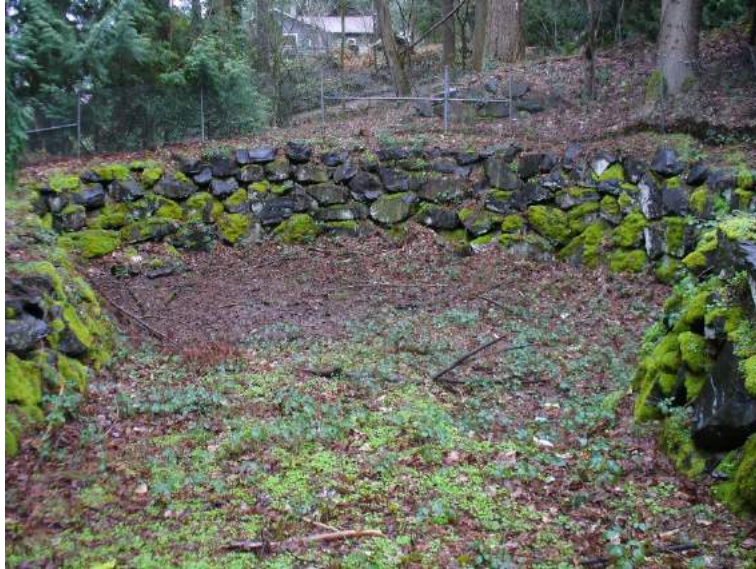
Site location: Infiltration facility (D93083) on corner of Louis Thompson Rd. and 205th Ave NE
Photo number: Up-7
Description: Looking north from Louis Thompson Rd. Pond is dry and shows no evidence of water.

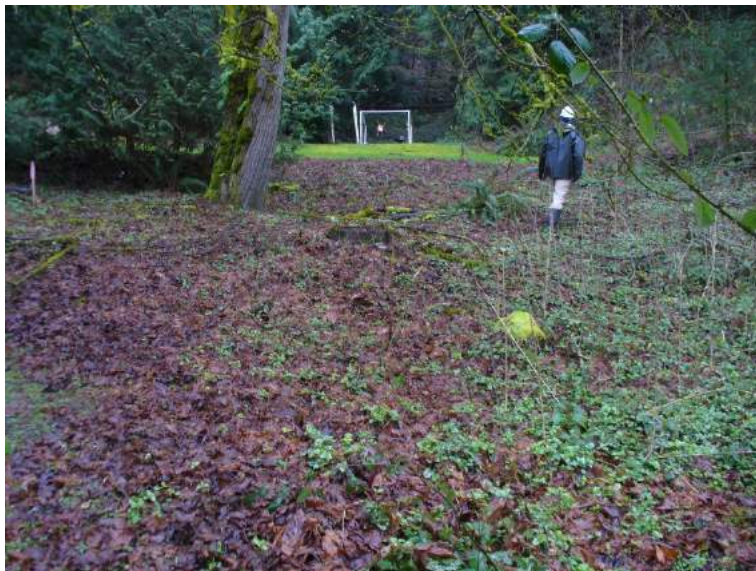
Site location: South of Eden Glen neighborhood near stormwater outfall (D90392)
Photo number: Up-8
Description: Looking north in approximate location of stormwater tightline outfall from Eden Glen neighborhood.

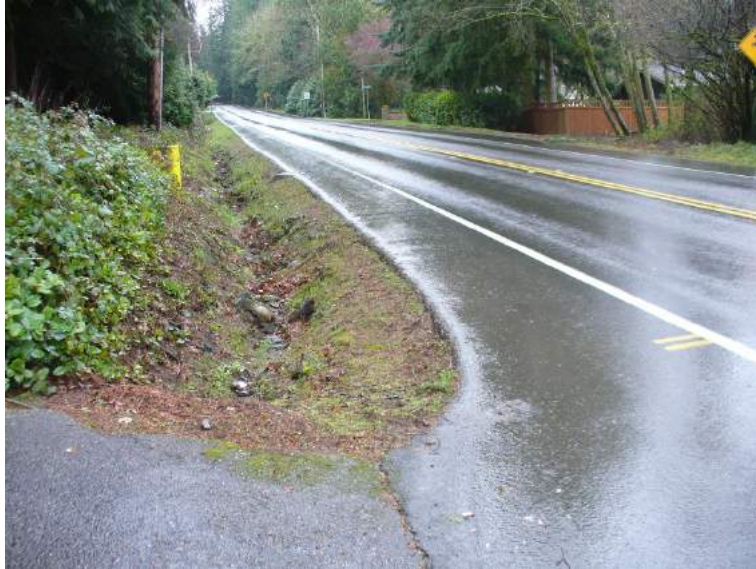
Photo number: Up-9

Site location: Ditch on north side of Louis Thompson Rd. near NE 3rd St and infiltration facility

Description: Roadside ditch is dry between NE 3rd and infiltration facility.

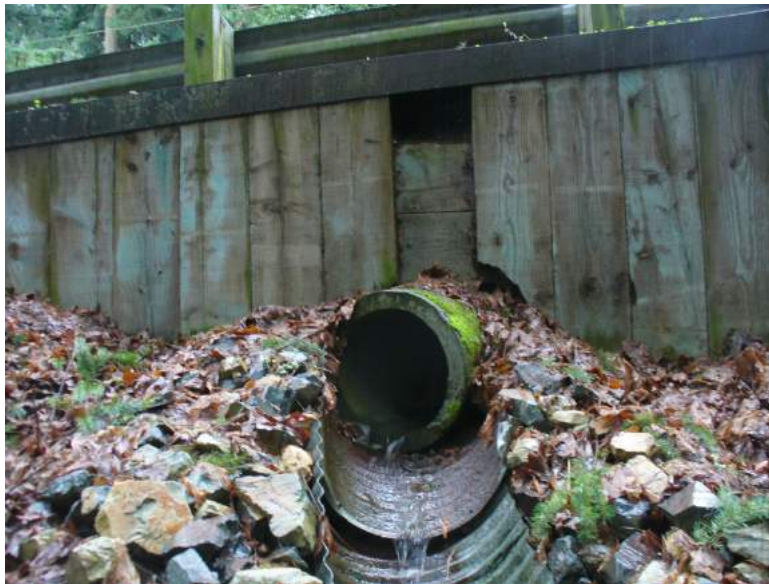
Photo number: Up-10

Site location: Culvert (Outfall 3) on south side of Louis Thompson Rd.

Description: Looking north up at culvert and half-pipe.

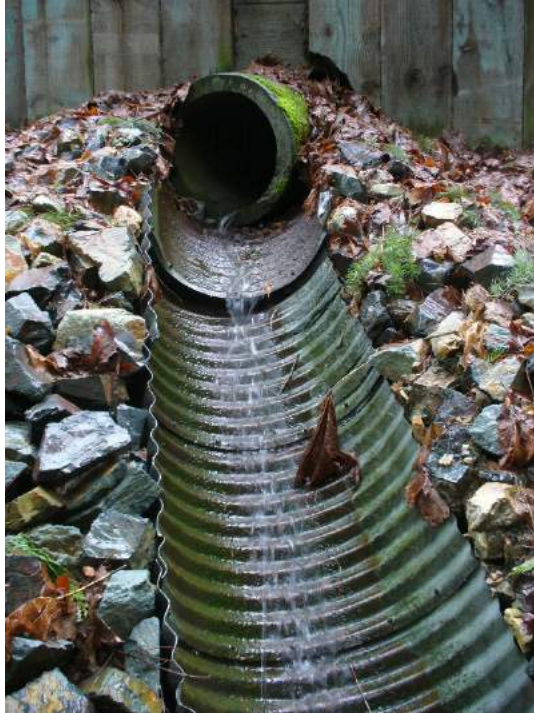
Photo number: Up-11

Site location: Same location as Photo Up-10

Description: Looking up at culvert (Outfall 3) on downslope side of Louis Thompson Rd. Location approximately 150 feet below this point is deeply incised and eroded.

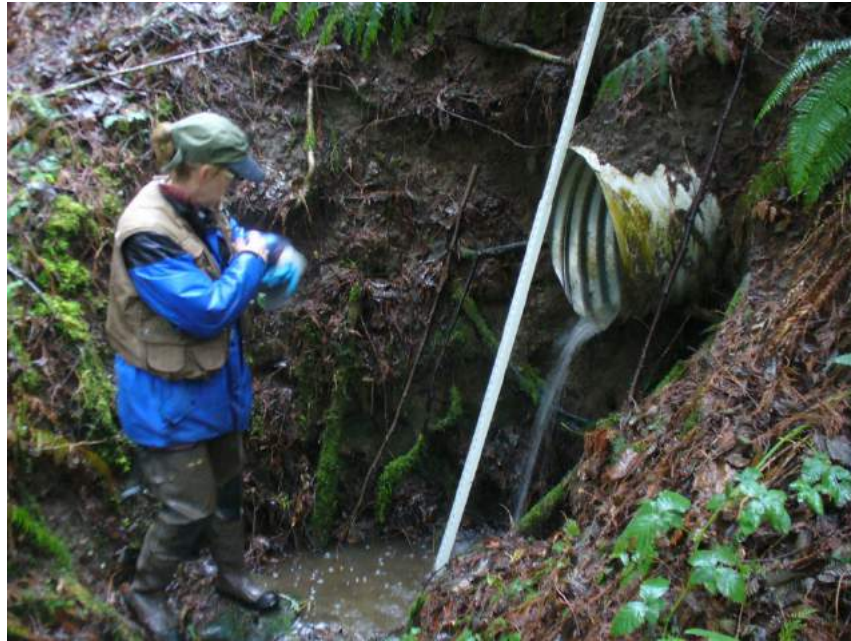
Photo number: Up-15

Site location: Private driveway culvert crossing (downstream side) downstream of Photo Up-14

Description: Culvert is perched approximately 3 feet above the channel bed.

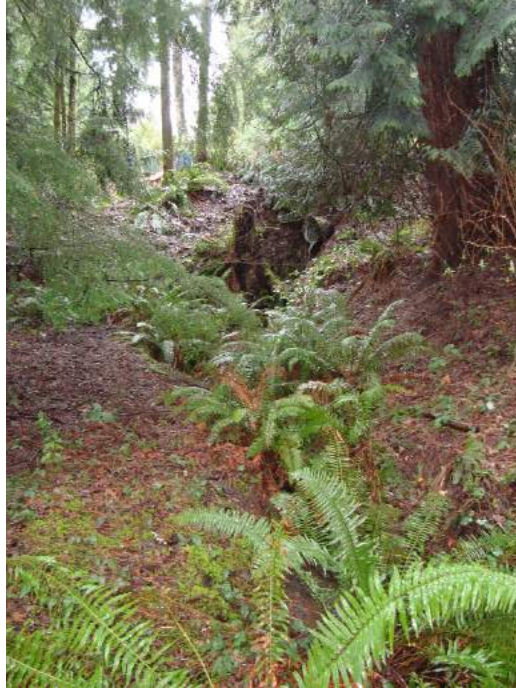
Photo number: Up-17

Site location: Downstream of perched driveway culvert

Description: Channel is incised.

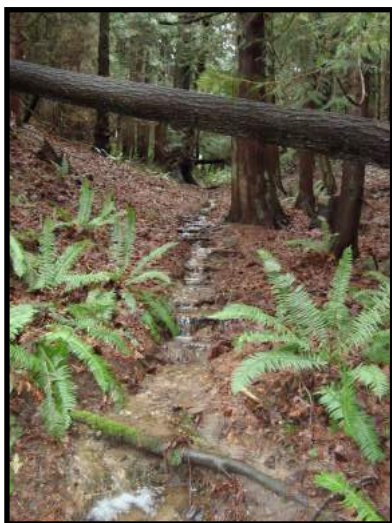
Channel erosion was also observed in the Tamarack ravine, between 208th Avenue NE and 205th Avenue NE. The ravine is downstream of a private stormwater outfall that discharges drainage from the upstream neighborhood.

Ravine erosion (left photo)

There are potential actions that could be taken by the private property owners in Tamarack to address citizen drainage concerns. Tamarack Drainage Project #1 is a tightline project that would contain drainage to minimize erosion in the ditches on NE 4th. Previous studies have evaluated options to manage Tamarack drainage. In 2013, the recommended option was to install drainage improvements on NE 4th and connect and improve stormwater pipes on 205th Ave NE to convey stormwater through the Tlinget neighborhood. This option did not include flow control and was selected because it connected to City right-of-way and did not involve easement acquisition. Tamarack Drainage Project #1 is a tightline that was another option considered during the 2013 options analysis. This option includes a flow control vault and is routed in a more direct flow path that would require easements on private property. The flow control component increases the planning level cost estimate compared to the Tlinget option, however, without flow control the costs are similar. The project summary sheet for Tamarack Drainage Project #1 is provided in Attachment 1.

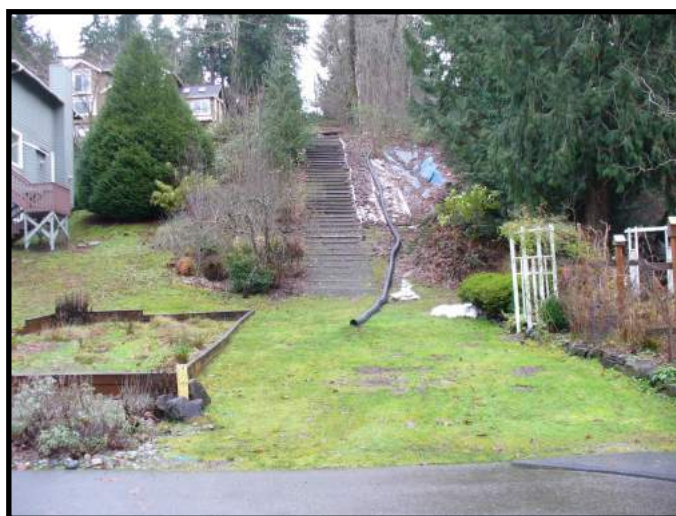
Ad-hoc stormwater drainage and failed slope (right photo)

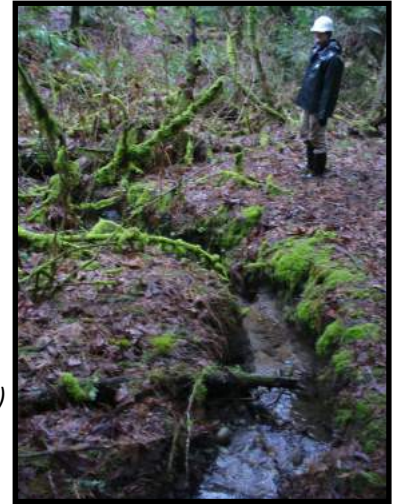
Stream channel erosion (right photo)

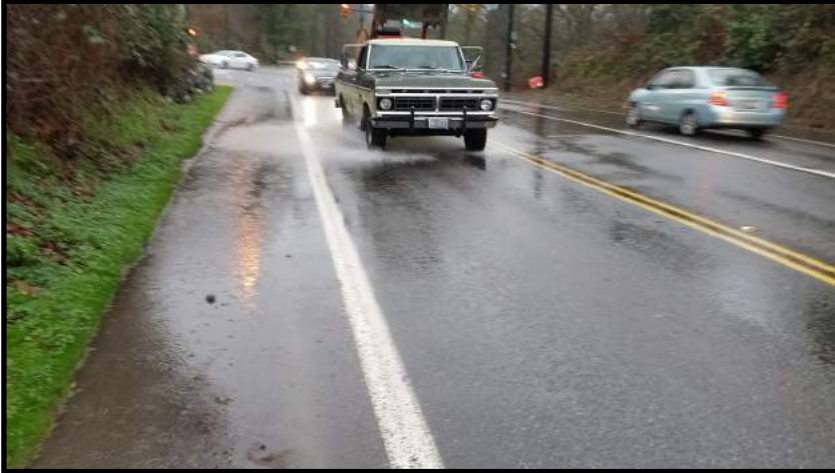
Pooling water on ELSP from seepage emanating from bank on left side of photo

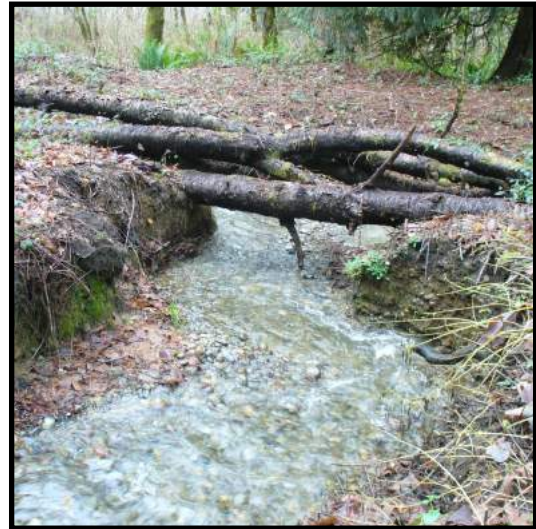
Zackuse Creek upstream of dogleg, looking downstream (west). Channel incised in several feet of sediment. January 2018.
