The Beaver Lake Monitor

A publication of the Beaver Lake Management District Advisory Board

<http://www.ci.sammamish.wa.us/BLMD.aspx#Home> • Volume 9, Issue 2 • December 2008

Beaver Lake Aquatic Plant Survey

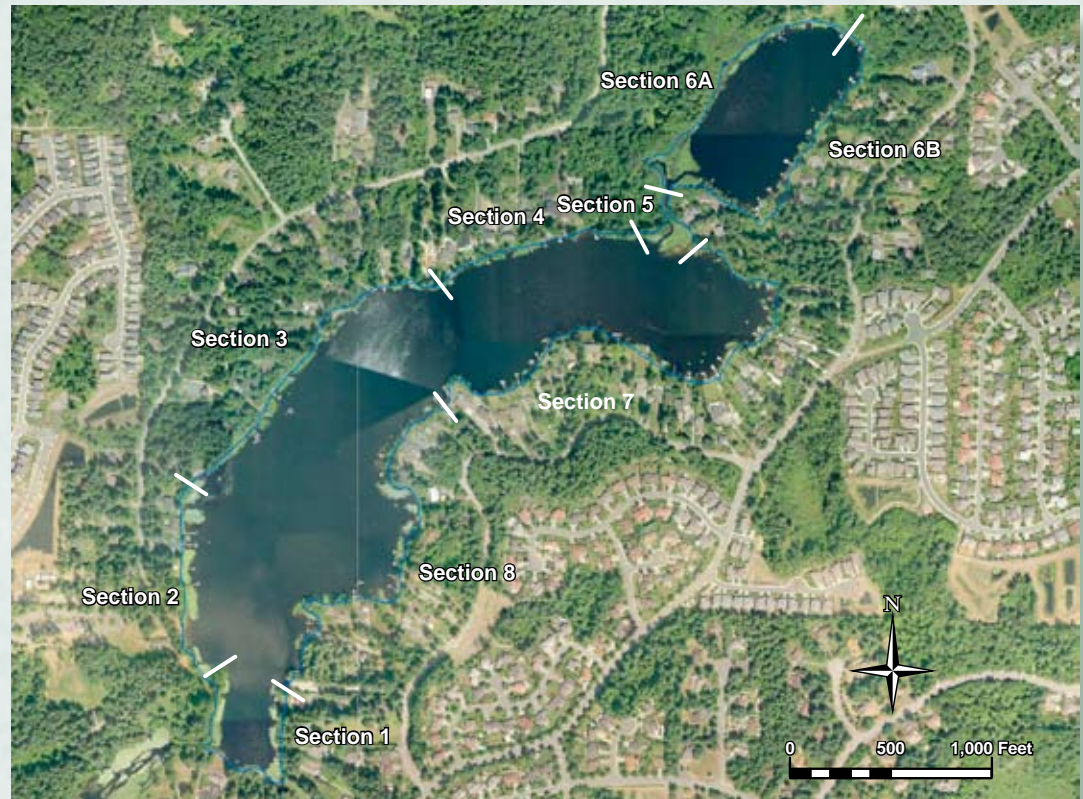
Figure 1. Sections surveyed for aquatic plants around Beaver Lake

The survey was structured similar to a King County effort in 1994-95, in which 36 lakes around the county were divided into shoreline sections and assessed for aquatic plant species and distributions. Both Beaver Lake basins in 2008 were assessed by the same eight survey sections and by methods similar to the 1995 report, with the exception that Beaver-1 (north basin) was split into two sections, 6A and 6B, to separate the wetland shoreline from the residentially developed shorelines. Armed with maps, a GPS, a weed rake, and a viewing tube, the KCLS staff started in section 1 (Figure 1) and proceeded clockwise around the lake, ending back at the boat launch.

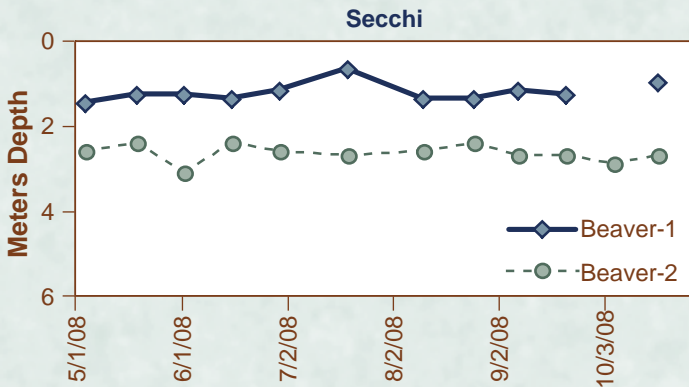
Secchi transparency measures water clarity, usually evaluated in the middle of the lake. While winter decreases in water clarity may be correlated with storm events that bring silt into the lake water, summer clarity is nearly always associated with algae populations and water color. Changes in water clarity often indicate something happening in the lake that should be investigated further.

In both basins, water clarity remained steady through the season. Beaver-1 (the north basin) is consistently less clear than Beaver-2 (the main basin). This is because the water in Beaver-1 is more highly colored due to a high quality wetland feeding the main tributary to the lake and to a wetland fringe along the western shoreline. The tea color is a natural feature of the lake, and the lake dwelling species are adapted to it.

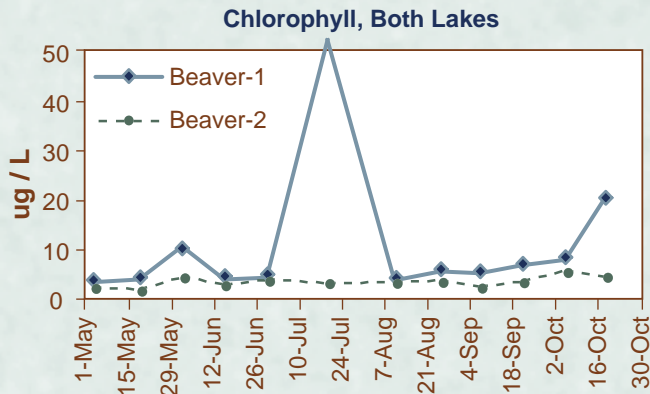
Throughout much of the season, chlorophyll in the two lake basins was very similar, although Beaver-1 was generally slightly higher than Beaver-2. There were three dates with exceptions: late May, Late July and at the end of the sampling period in October. On all three occasions, Beaver-1 was significantly higher than Beaver-2, reflecting its overall higher productivity.
