TECHNICAL MEMORANDUM

DATE: February 26, 2015
TO: King County
FROM: Paul Fendt
SUBJECT: Evaluation of Existing Drainage Structures for Replacement in the South Sammamish Segment
CC: Craig Buitrago, Jenny Bailey
PROJECT NUMBER: 554-1521-075 (20/05)
PROJECT NAME: East Lake Sammamish Trail

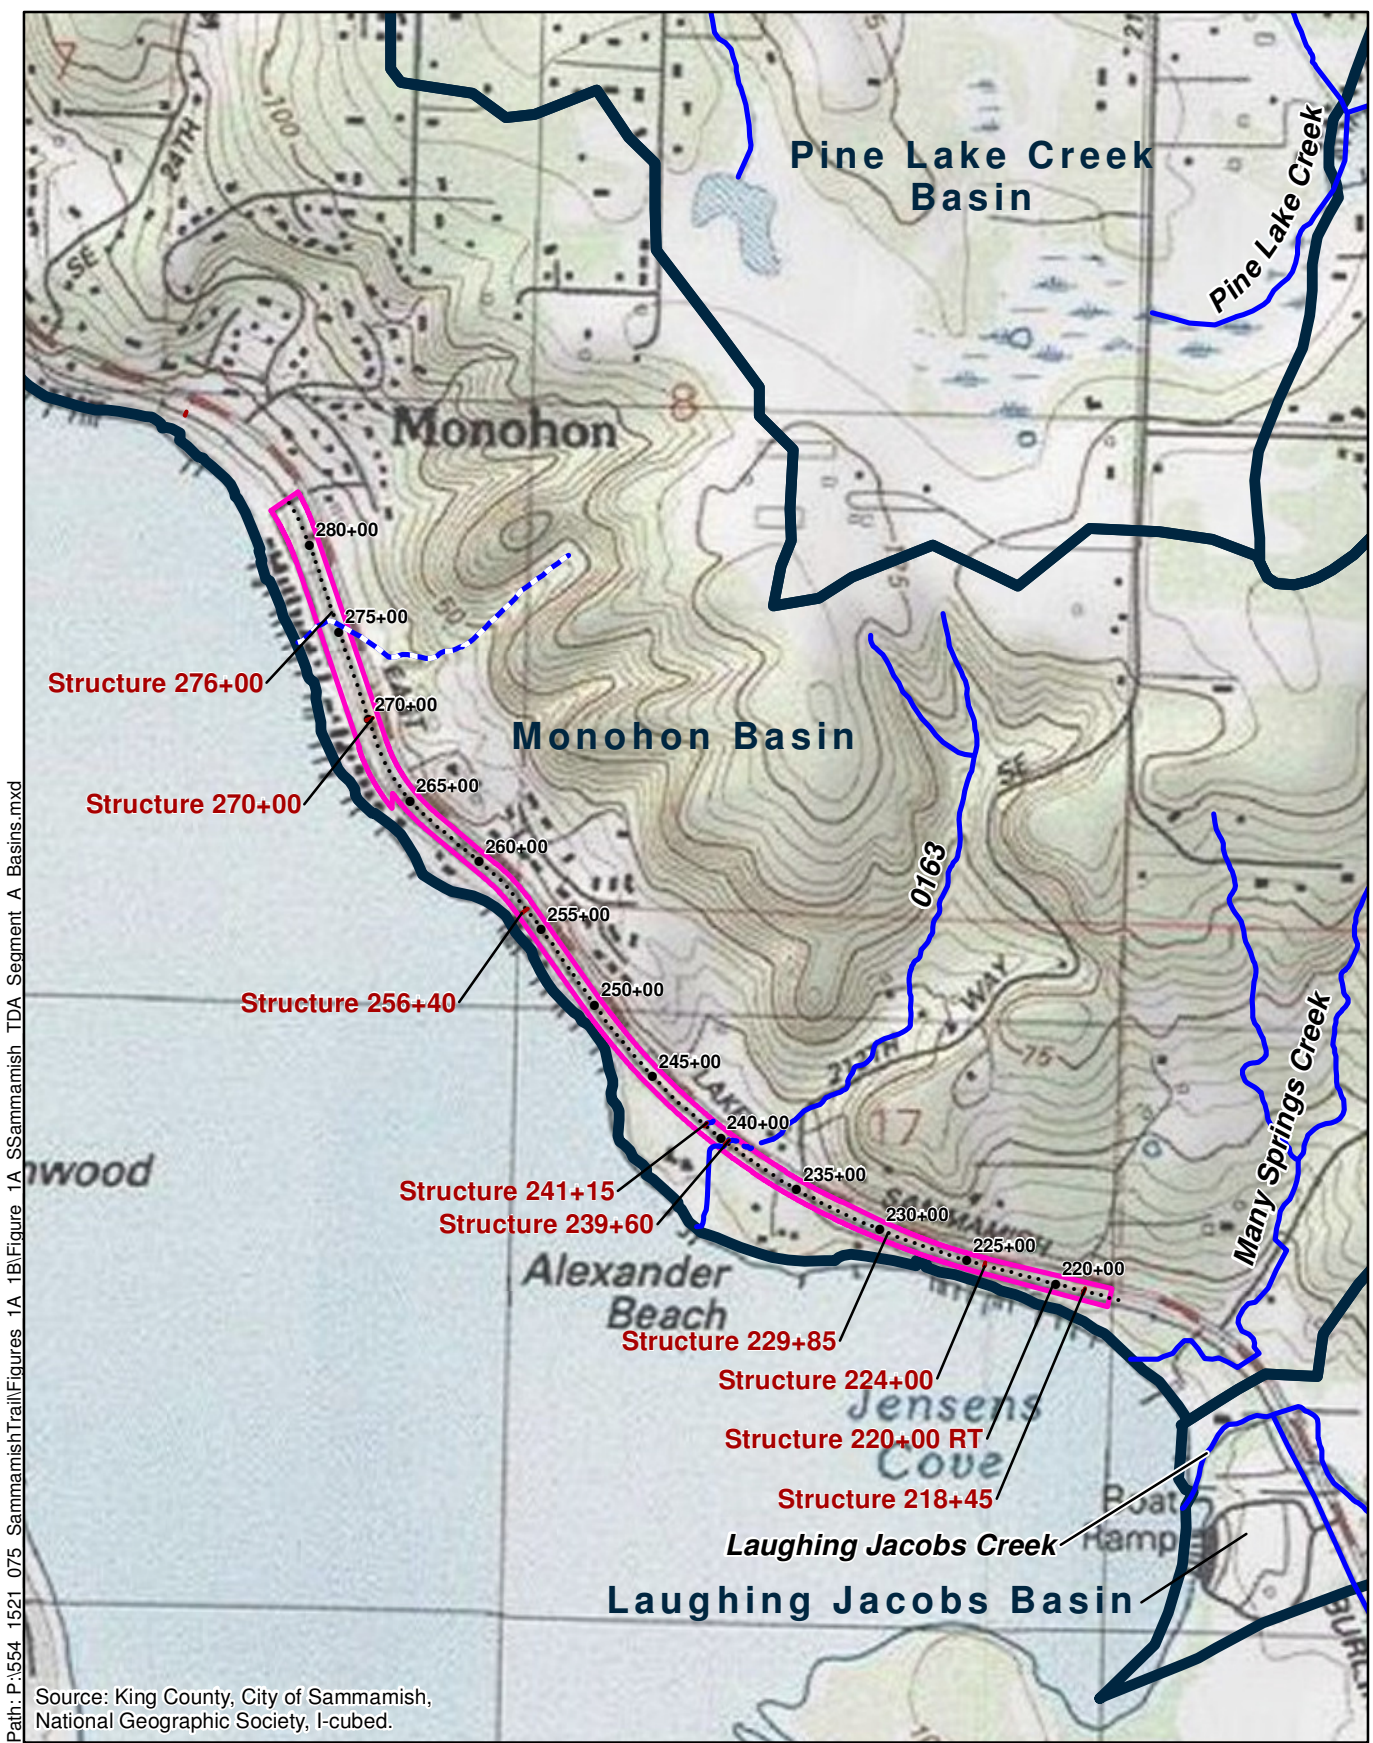
**Figure 1A
Drainage Structure
Locations**

Each of the screening steps were performed on all 41 structures in the South Sammamish Segment (Figures 1A and 1B), which includes nine structures in South Sammamish Segment A, shown as the southern-most nine structures on Figure 1A (stations 218+45 through 276+00). Consequently, if additional data is found that may change a decision on a culvert for one screen, other screens may be reviewed to confirm the original decision. This analysis was a combination of desk top reviews of maps and plans, site photographs, and personal knowledge of the sites based on multiple field visits. Additional field verification may be needed to confirm findings in selected areas.

The 41 structures in South Sammamish have been identified by their station location along the corridor to provide a unique identifier for each drainage path. Figures 1A and 1B shows the trail stationing, location of the 41 structures, and general drainage catchment areas as defined in the King County GIS hydrography layer.
